**Technical Service Bulletin (TSB)**  
**Flash: Radio Frequency Hub Module (RFHM) Update**

| REFERENCE: | TSB: 08-188-23<br>GROUP 08 - Electrical | Date: | August 2, 2023 | REVISION: | — |
| VEHICLES AFFECTED: | 2023 (VF) RAM ProMaster<br>This bulletin applies to vehicles built on and before June 08, 2023 (MDH 0608XX) equipped with the 3.6L V6 24V VVT Engine (Sales Code ERF). | | | MARKET APPLICABILITY:<br><input checked="" type="checkbox"/> NA<br><input type="checkbox"/> EE<br><input type="checkbox"/> SA<br><input type="checkbox"/> IAP<br><input type="checkbox"/> MEA<br><input type="checkbox"/> CH | |

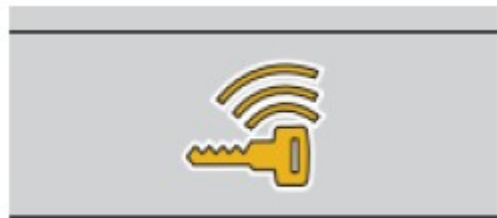
**Fig. 1**  
**RFHM Lamp**

| CUSTOMER SYMPTOM: | The customer may experience a Malfunction Indicator Lamp (MIL) illumination. Upon further investigation the technician may find one or more of the following Diagnostic Trouble Code (DTCs): <ul style="list-style-type: none"><li>• B1053-64 RFHM (Kin Communication) - Signal Plausibility Failure Set In The RF Hub.</li><li>• B1A7D-2F Start Button - Signal Erratic.</li></ul> Customers may also experience one or more of the following: <ul style="list-style-type: none"><li>• Messages shown on the Instrument Panel Cluster (IPC):</li><li>• Service Passive Entry Vehicle will not Shut Off or Restart.</li><li>• To Shut Off Vehicle, See Vehicle Settings (if the vehicle speed is lower than 4 KMH) (2.4 MPH).</li><li>• Engine will not shut off.</li><li>• Lamp lit on IPC (Fig. 1) .</li></ul> | | | | |
| CAUSE: | RFHM software | | | | |

This bulletin involves updating the RFHM with the latest available software.
