| REFERENCE: | TSB: 08-187-23<br>GROUP 08 - Electrical | Date: | August 2, 2023 | REVISION: | — |
| VEHICLES AFFECTED: | 2022 (VF) RAM ProMaster<br>This bulletin applies to vehicles equipped with the 3.6L V6 24V VVT Engine (Sales Code ERF). | | | MARKET APPLICABILITY:<br><input checked="" type="checkbox"/> NA<br><input type="checkbox"/> EE<br><input type="checkbox"/> SA<br><input type="checkbox"/> IAP<br><input type="checkbox"/> MEA<br><input type="checkbox"/> CH | |

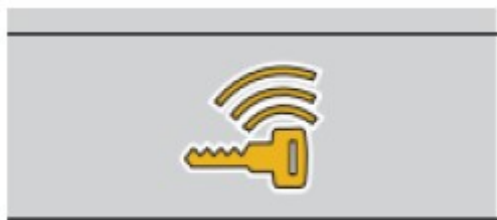
**Fig. 1**  
**RFHM Lamp**

| CUSTOMER SYMPTOM: | The customer may experience a Malfunction Indicator Lamp (MIL) illumination. Upon further investigation the technician may find one or more of the following Diagnostic Trouble Code (DTCs): <ul style="list-style-type: none"><li>• B1053-64 RFHM (Kin Communication) - Signal Plausibility Failure Set In The RF Hub.</li><li>• B1A7D-2F Start Button - Signal Erratic.</li></ul> Customers may also experience one or more of the following: <ul style="list-style-type: none"><li>• Messages shown on the Instrument Panel Cluster (IPC):</li><li>• Service Passive Entry Vehicle will not Shut Off or Restart.</li><li>• To Shut Off Vehicle, See Vehicle Settings (if the vehicle speed is lower than 4 KMH) (2.4 MPH).</li><li>• Engine will not shut off.</li><li>• Lamp lit on IPC (Fig. 1) .</li></ul> | | | | |
| CAUSE: | RFHM software | | | | |

This bulletin involves updating the RFHM with the latest available software.

3. Reprogram the RFHM with the latest software. Detailed instructions for flashing control modules using the wiTECH Diagnostic Application are available by selecting the application "HELP" tab.
4. Clear all DTCs that may have been set in any module due to reprogramming. The wiTECH application will automatically present all DTCs after the flash and allow them to be cleared.
