## Technical Service Bulletin (TSB) Cylinder Head Screw Not Specific

| REFERENCE: | TSB: 09-014-23<br>GROUP 09 - Engine | Date: | August 29, 2023 | REVISION: | – |
| CAUSE: | Incorrect cylinder head-to-block fasteners. | | | | |

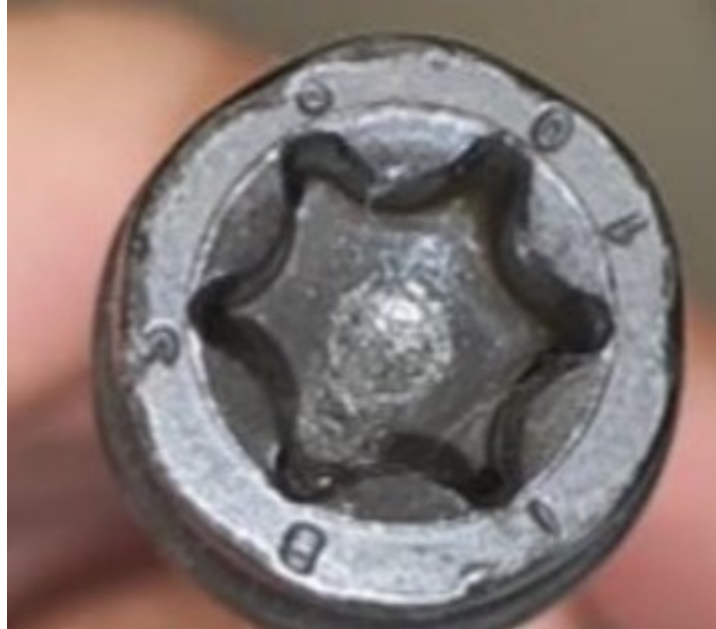
**Fig. 1**  
**Correct Head fastener**

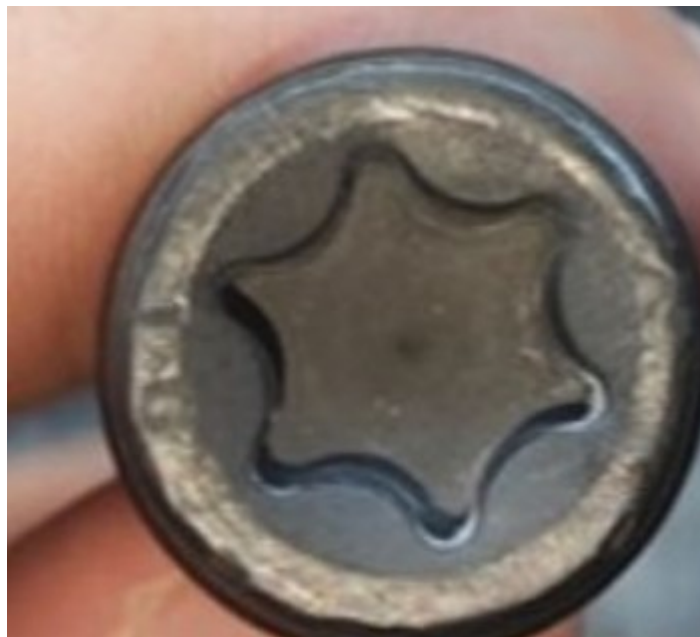
**Fig. 2**  
**Incorrect Head Fastener**

**NOTE: Incorrect vendor markings: ([Fig. 2](#))**

6. If there are no markings on the screws ([Fig. 2](#)) , and it is an **unsold** vehicle, proceed to [Step 10](#) of the Inspection Procedure. But if it is a **sold** vehicle, proceed to [Step 1](#) of the Repair Procedure.
7. If there are markings on the screws, proceed to [Step 8](#).

11. Remove the camshaft. Refer to the detailed service procedures available in DealerCONNECT/Service Library under: 09 - Engine, 1.3L I4 16V MultiAir Turbo / Cylinder Head / Camshaft, Engine / Removal and Installation.
12. Replace the incorrect screw(s) with the correct screws.
