| <b>HYUNDAI</b><br><b>Technical Service Bulletin</b> | GROUP<br><b>AUTOMATIC<br/>TRANSMISSION</b> | NUMBER<br><b>23-AT-008H-1</b> |
| <b>SUBJECT:</b> AUTOMATIC TRANSAXLE (8-SPEED FWD)<br>POSITION SENSOR DTC P070500, P070512, P070514,<br>P07051C, P070600, P070661 & P070696 DIAGNOSIS AND<br>REPLACEMENT | | |

***This TSB supersedes TSB 23-AT-008H to add harness information for Tucson (NX4/NX4A), Step 7.***

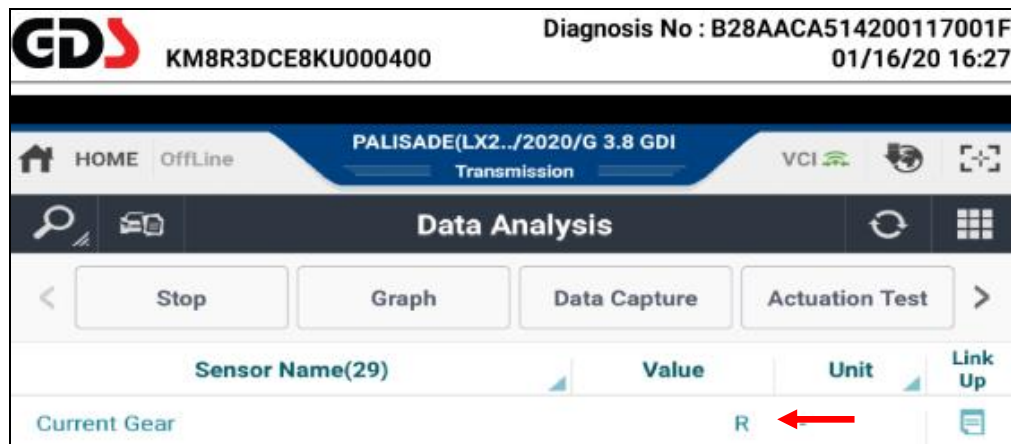
1. Start the engine.
2. Attach a GDS and check for DTC in the “Automatic Transaxle” menu. **Record the DTC and description.** Delete the DTC.
3. Select **Data Analysis, A/T** menu and **Current Gear**. Depress the brake pedal and move the shift lever through all gears (P, R, N and D) and monitor the **Current Gear**. Confirm the GDS and the indicator on the cluster shows all gears. Turn the ignition **OFF**.

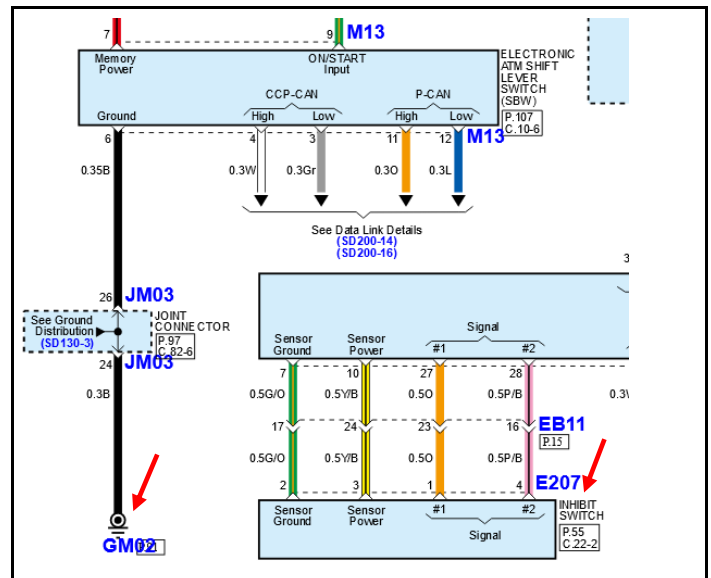
6. Check the grounds for the electronic shift lever. (Refer to ETM, SD450-1).  
Turn the ignition and headlights on. Use a DVOM to check the voltage drop between the wiring terminal and ground.

**Specification: Less than 0.2 V.**

- If more than 0.2V, clean the terminal and bolt threads and tighten the bolt.
- If less than 0.2V, go to Step 7.

**Torque: 7~9 lb-ft, 1.0~1.2kgf.m, 10~12 N.m**

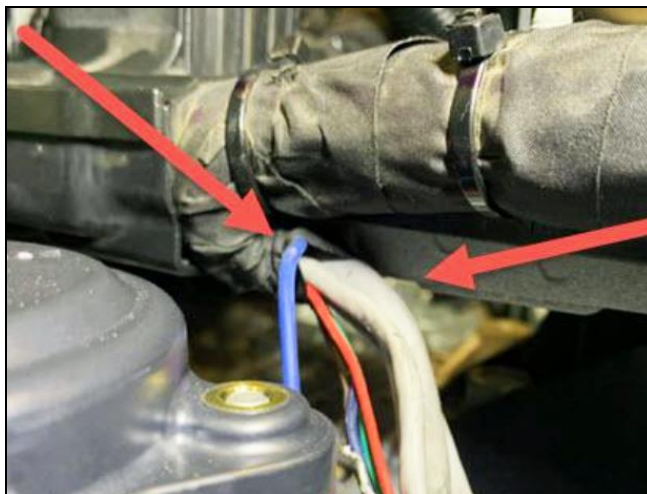
**Santa Fe (TMa) 2.5L – VINs begin with 5NM**  
Carefully unwrap the harness protector in the area shown below. Check the insulation on the wires to see if the insulation has been damaged by contact with the battery tray. If so, repair or replace the control harness.

If replacing the control harness, make sure the replacement harness does not contact the battery tray/other components. Otherwise, the harness may become damaged again.

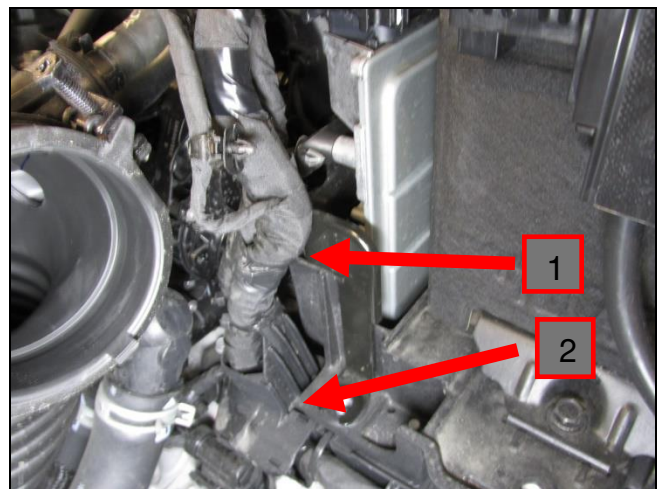
**Tucson (NX4/NX4A) 2.5L –VINs KM8 or 5NM**  
Carefully unwrap the harness protector in the areas shown below:  
1. Check if the insulation has been damaged by contact with the metal bracket.  
2. Check for broken wires in the area of the 90 degree bend in the harness.  
If so, repair or replace the control harness.

Damage to the wiring harness may still be present, even if there is no external damage to the harness protector. Even slight damage to the wiring harness can cause these faults.

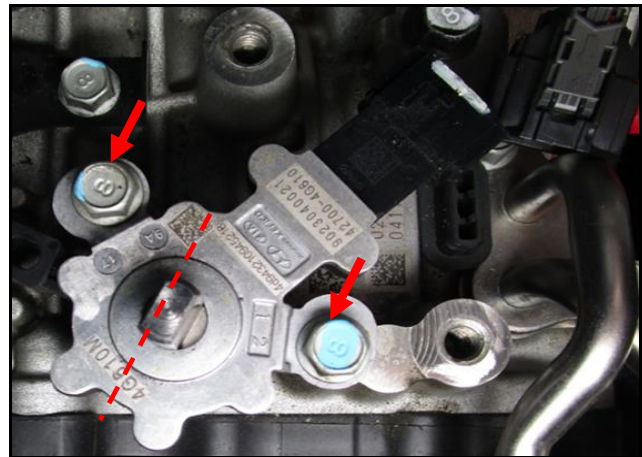
**NOTE:** The manual valve is shown in the Park position.

12. Remove 2 mounting bolts and remove the position sensor.
- Install a new position sensor.
- Install 2 bolts and loosely tighten the bolts.
