## Technical Service Bulletin

23-01-075H

IONIQ 5 (NE1)

ACTIVE AIR FLAP (AAF) ACTUATOR REPLACEMENT  
(SERVICE CAMPAIGN TAI)

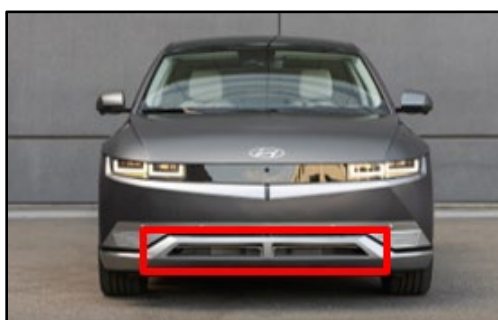
**Description:** This bulletin provides information on replacement of the Active Air Flap (AAF) actuator on 2022MY Ioniq 5 (NE1) vehicles that may exhibit AAF warning signs and DTC U028400 while driving. The AAF may not open or close when the DTC U028400 is active due to unstable power supply to the actuator. Follow the procedure in this bulletin to replace the AAF actuator and erase the DTC code.
