| <br><b>Technical Service Bulletin</b> | <b>GROUP</b><br><br><b>CAMPAIGN</b> | <b>NUMBER</b><br><br><b>23-01-069G-1</b> |
| <b>SUBJECT:</b> DTC P1A9096 CHECK FOR ICCU & FUSE REPLACEMENT AND ICCU SOFTWARE UPDATE (SERVICE CAMPAIGN 907G) | | |

***This bulletin supersedes 23-01-069G to add 2023-24MY GV70 Electrified (JK1a EV) vehicles.***

**Description:** Certain 2023MY G80 Electrified (RG3 EV), 2023-24MY GV60 (JW1 EV), and 2023-24MY GV70 Electrified (JK1a EV) vehicles may have a condition where low 12V auxiliary battery charging occurs due to an ICCU (Integrated Charge Control Unit) fault and may set the following DTC P1A9096 – "DC/DC Converter Input Voltage Sensor Fault".

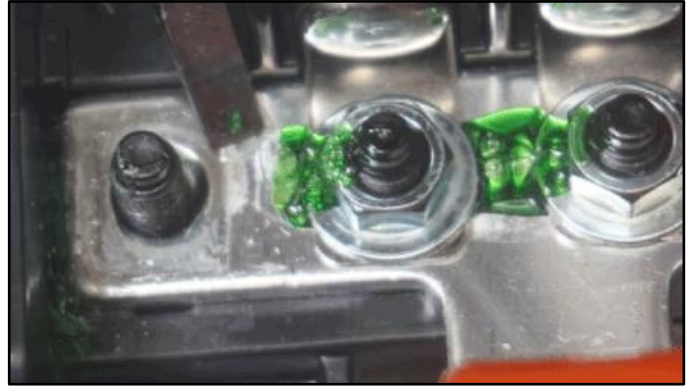
Any foreign substance in this area may cause poor contact between terminals.

- D4. After removing the bus bar, remove Loctite residue with a screwdriver or other tool.

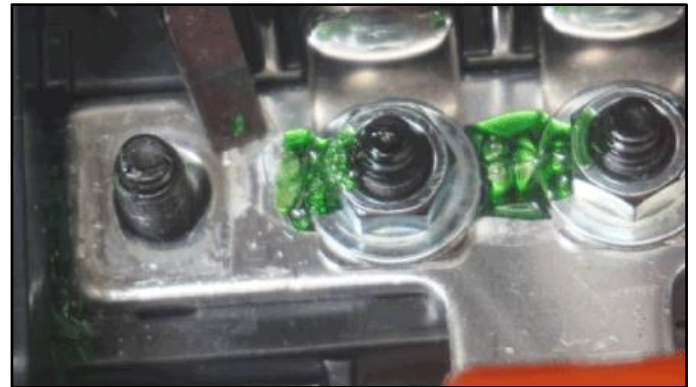
Any foreign substance in this area may cause poor contact between terminals.

- E5. After removing the bus bar, remove Loctite residue with a screwdriver or other tool.
