# Service Bulletin

Bulletin No.: 22-NA-170

**Subject:** Information on Possible Crank No Start or Extended Crank with DTC P12A6 or Service Safety Restraints message on DIC, with B0073

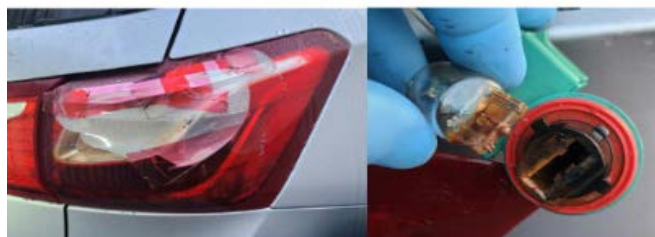
6144660

1. Inspect the right tail lamp for signs of damage or standing water. If there is damage or standing water, inspect the tail lamp bulb connectors for signs of corrosion or water. Replace the tail lamp and bulb connector, if corroded, to prevent a repeat concern.

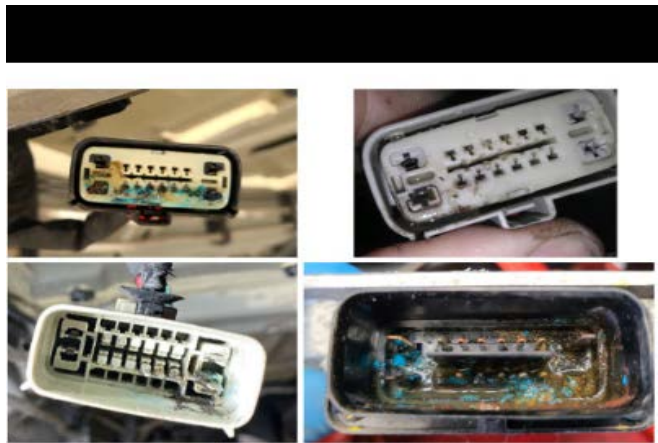
6144661

2. If the tail lamp and connector are damaged, continue with next step. If the tail lamp and connector are ok, continue with diagnosis following SI for the appropriate DTC.
3. For DTC P12A6, inspect connector X350 for signs of water intrusion or corrosion. X350 is the Fuel Tank Harness to Body Harness connector, under the vehicle.

Note: Examples above of corrosion which can cause a poor connection resulting in no-start. The water intrusion can also short terminals together, which can keep the fuel pump running after key-off, draining the battery.

- If water intrusion or corrosion is found, make repairs by replacing the connector with terminated leads on the body harness side, or by replacing the fuel pump control module harness, or both repairs if both sides show water intrusion, corrosion and/or damage.
