# Technical Service Bulletin

## 35 Gearbox Malfunction Warning, DTC P0C2900, P176F00, P176E00, P175E00, P175D00, P189900, P060700, P081000 in the TCM

35 23 46 2050723/4 October 9, 2023. Supersedes Technical Service Bulletin Group 35 number 23-43 dated August 2, 2023, for reasons listed below.

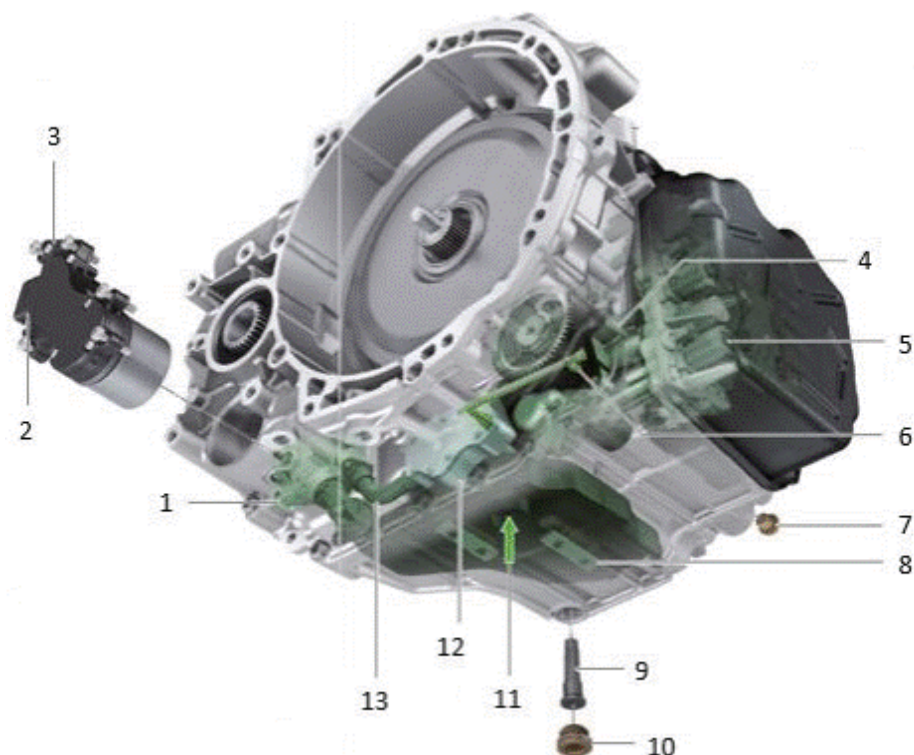
**Figure 1.** 0GC Gearbox Components.

Component related issue of auxiliary hydraulic pump (Figure 1).

Replace the auxiliary hydraulic pump according to the instructions attached to this TSB (Figure 3), and the parts information listed below. The event memory of the gearbox electronics (diagnostic address 002) must then be erased according to the attached instructions.

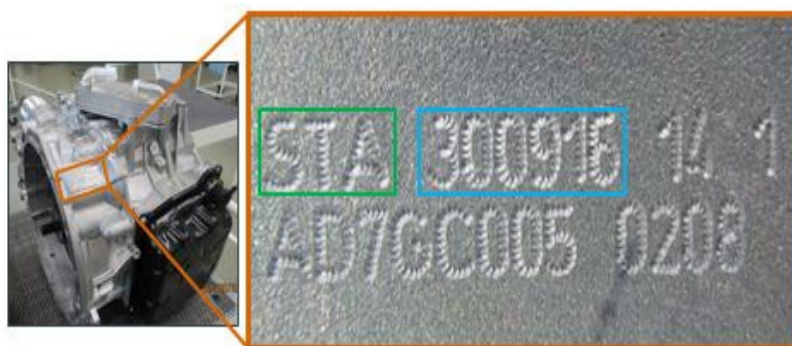
**Figure 2:** Transmission identification example.

Gearbox code: STA (green box).

Gearbox Production date: **300916** = **03.09.2016** (blue box).

- If the gearbox production date is after 26.09.2017, this TSB does not apply. Proceed according to Guided Fault Finding. Please note that in this case, the costs for the repair cannot be billed under this TSB.
- If the gearbox production date is on or before 26.09.2017, continue as described below.
