# Technical Service Bulletin

## 93 DTCs P0C4A00, P2B2800 and/or P0CFF00 Stored in the Hybrid Battery Management control unit

93 23 31 2068363/4 October 2, 2023. Supersedes Technical Service Bulletin Group 93 number 23-06 dated May 9, 2023 for reasons listed below.s

| Model(s) | Year | VIN Range | Vehicle-Specific Equipment |
|---|---|---|---|
| Q4 e-tron, and<br>Q4 Sportback e-tron | 2022 – 2024 | All | Not Applicable |

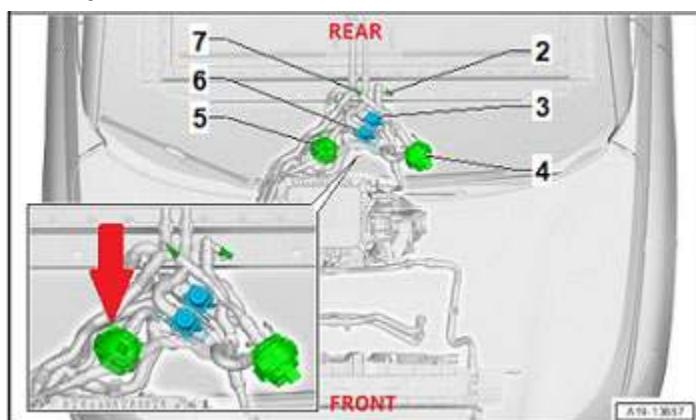
**Figure 1:** V590 location.

- The coolant pump (V590) must be replaced according to the Workshop Manual.
