# MIL On With DTC(s) P060694 and/or P060647

## Applicability

## Introduction

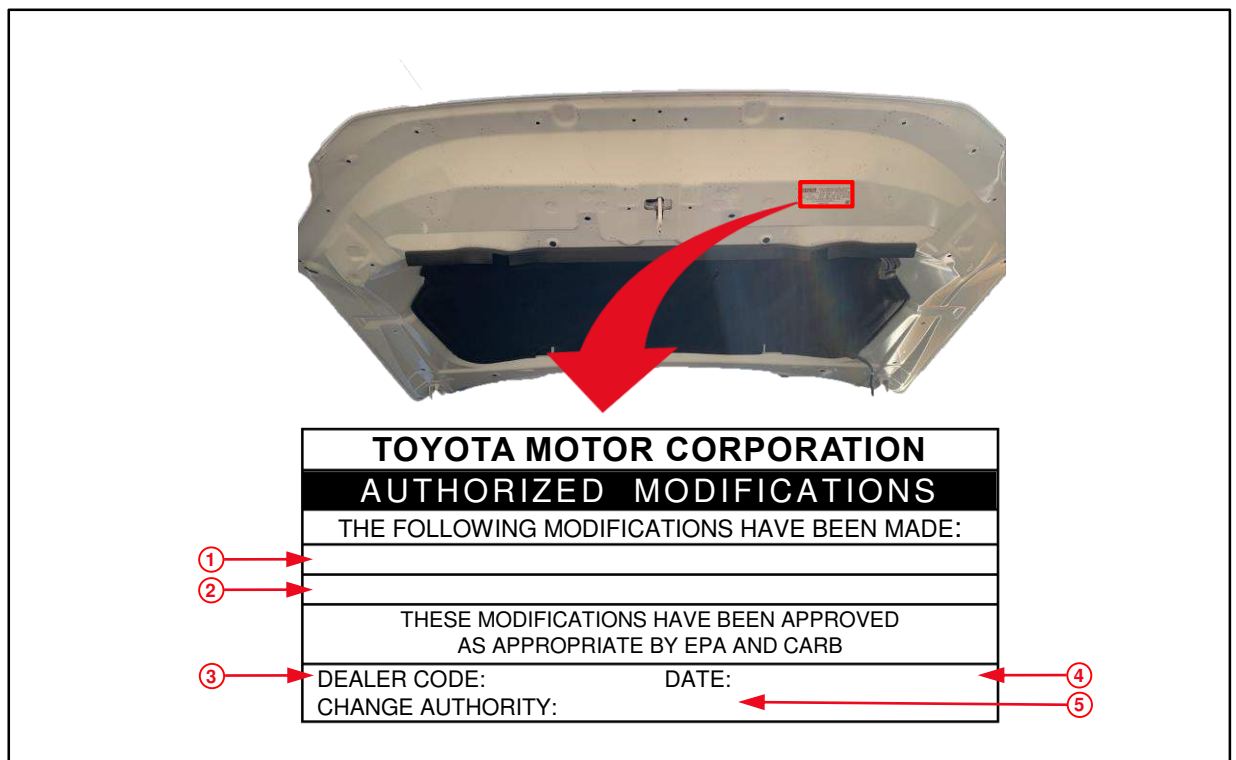
**Figure 1. Location of Authorized Modifications Label on 2022 – 2023 Tundra HV and 2023 Sequoia HV**

2. Use Techstream to confirm if the ECM (PCM) calibration has been updated and check for the Authorized Modifications Label affixed to the vehicle in the location shown below.  
Is the calibration ID listed in Techstream and on the label the latest ECM (PCM) calibration?
  - **YES** — This bulletin does NOT apply. Continue diagnosis using the applicable Repair Manual.
  - **NO** — Continue to step 3.

4. Prepare and install the Authorized Modifications Label.
  - A. Using a permanent marker, enter the following information on the label:
    - ECM (PCM) part number [*Refer to the **Parts Information** section for the **NEW PART NUMBER***]
    - Calibration ID(s) [*Refer to the **Calibration Information** section for the **NEW CALIBRATION ID***]
    - Dealer Code
    - Repair Date
    - Change Authority [***This bulletin number***]
  - B. Install the Authorized Modifications Label onto the vehicle at the location shown in Figure 1. The Authorized Modifications Label is available through the MDC, P/N 00451-00001-LBL.
5. Test-drive the vehicle to confirm proper operation.
