# Technical Service Bulletin

## 01 MIL on, Whistling noise, leaking air Bank 2 - DTC P2ADF00, Engine Crankcase breather

01 23 87 2071318/3 October 23, 2023. Supersedes Technical Service Bulletin Group 01 number 23-78 dated September 20, 2023 for reasons listed below.

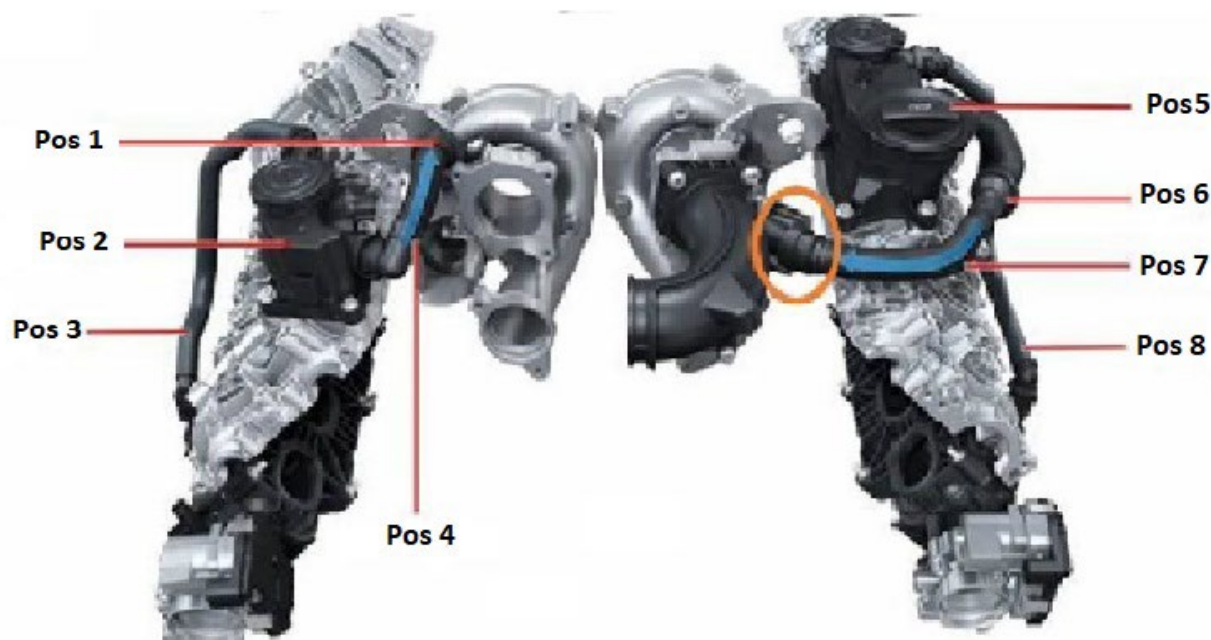
- **DTC P2ADF00** Intake Air System Leak Bank 2 (**must be stored**).
- **DTC P227900** Intake Air System Leak Bank 1 may be stored, if so please also perform service solution in TSB 2069351.

- Item 1: Non-return valve
- Item 2: Oil separator for bank 1
- Item 3 Part load breather line for bank 1
- Item 4: Full load breather line for bank 1
- Item 5: Oil separator for bank 2
- Item 6: Non-return valve
- **Item 7: Full load breather line for bank 2**
- Item 8: Part load breather line

In this case, replace the full load breather line for cylinder bank 2.

1. Do not replace the oil separator for bank 1 or bank 2 or the part load breather lines.
  - a. Please refer to image of the crankcase from the Self Study Program 920493 as a guide.
