# Technical Service Bulletin

**01 Vehicle start system warning is displayed in cluster, DTC(s) P086D00, P086E00 stored in the ECM**  
01 23 88 2071791/1 October 24, 2023.

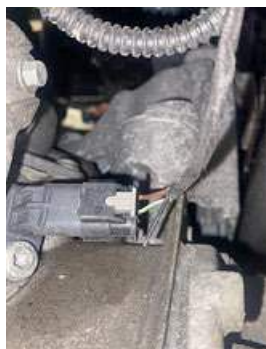
On vehicles manufactured within a specific period, the supply line to the gearbox neutral position sender G701 may be too short.

**Figure 1:** G701 Wire damage.

Check the wiring at the gearbox neutral position sender G701 (Figure 1).

If one of the wires is damaged, repair all 3 wires using wire repair set **VAS 1978 B**.

Lengthen the 3 wires by 20 mm so that the problem cannot reoccur.
