# Technical Service Bulletin

## 91 No diagnostics communication to the telematics control module (ConBox); DTC U142100

91 23 36 2070942/2 October 26, 2023. Supersedes Technical Service Bulletin Group 91 number 23-15 dated July 19, 2023 for reasons listed below.

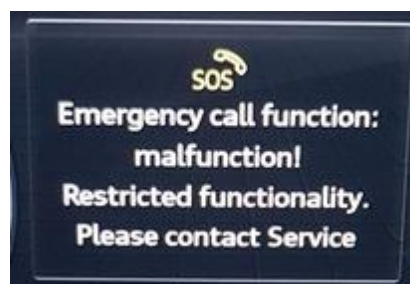
- An SOS Warning might be displayed in the instrument cluster (Figure 1).

**Figure 1.** Emergency call malfunction warning.

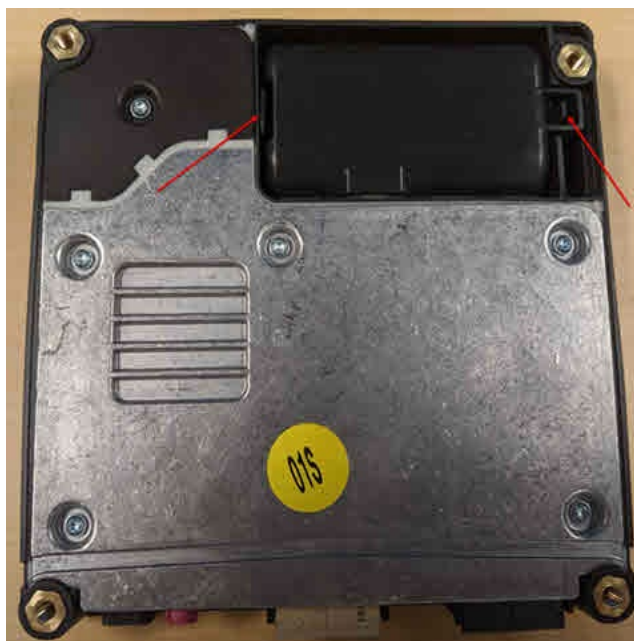
**Figure 2.** Backup battery compartment location.

2. Open the battery compartment of the control module for the emergency call module and communication unit, -J949- (address word 0075), and disconnect the backup battery (Figures 2 - 3).

3. Wait approximately one minute, then reinstall the backup battery back into the control module for the emergency call module and communication unit, -J949- (address word 0075).

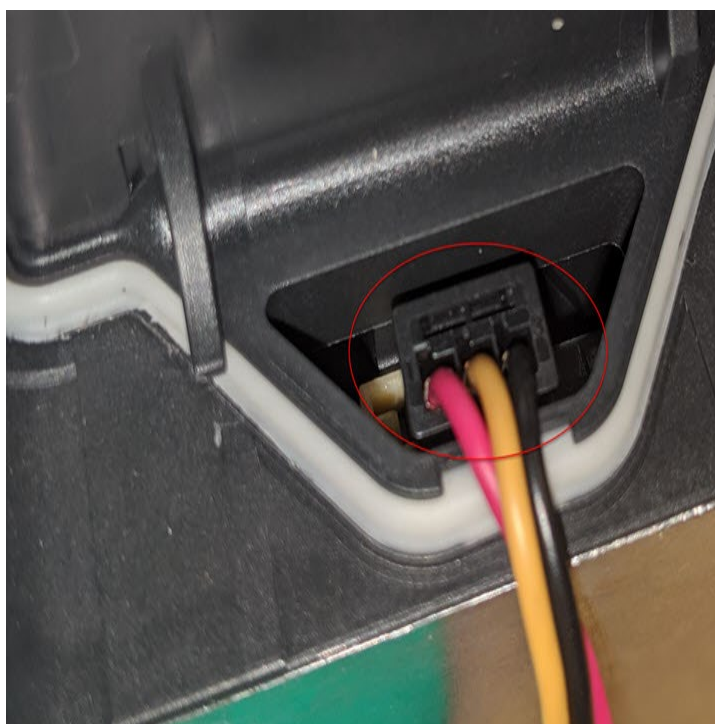
**Figure 3.** Backup battery connector (no release mechanism).
