## Technical product information

| <b>Topic</b> | Bentley dynamic ride system warning - DTC P0B2500: Hybrid/EV Battery "A" Voltage low' stored (48 volt system) |
| <b>Transaction No.</b> | 2068946/4 |

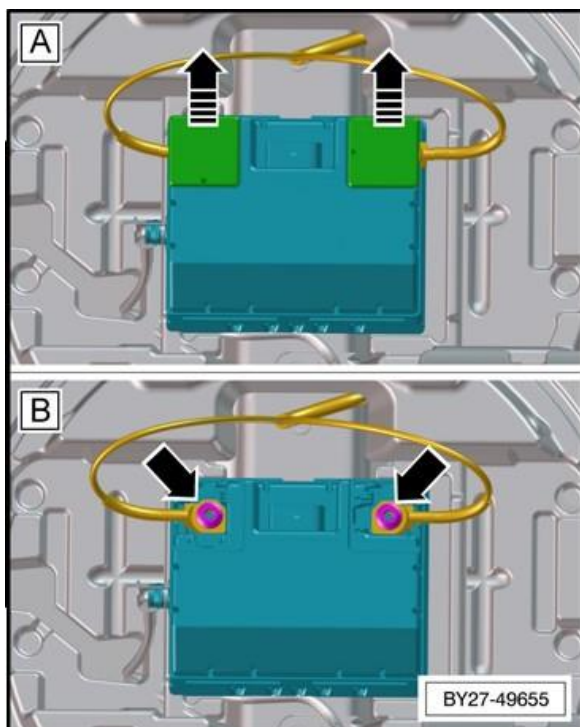
Figure 1

Possible internal fault with super capacitor

- Referring to Rep.Gr 27 - Deactivate the 48 volt system - Refer to 48 volt system - To activate and deactivate
- Referring to Rep.Gr 27 - Check the security of the super capacitor positive and negative terminals (Figure 1) as follows:
  - Remove the caps (A) from the terminals
  - Check the security of the positive and negative terminals
