# Technical product information

| Topic | Bentayga - Engine oil pressure warning |
| Transaction No. | 2045686/6 |
| Release date | 25-Sep-2023 |

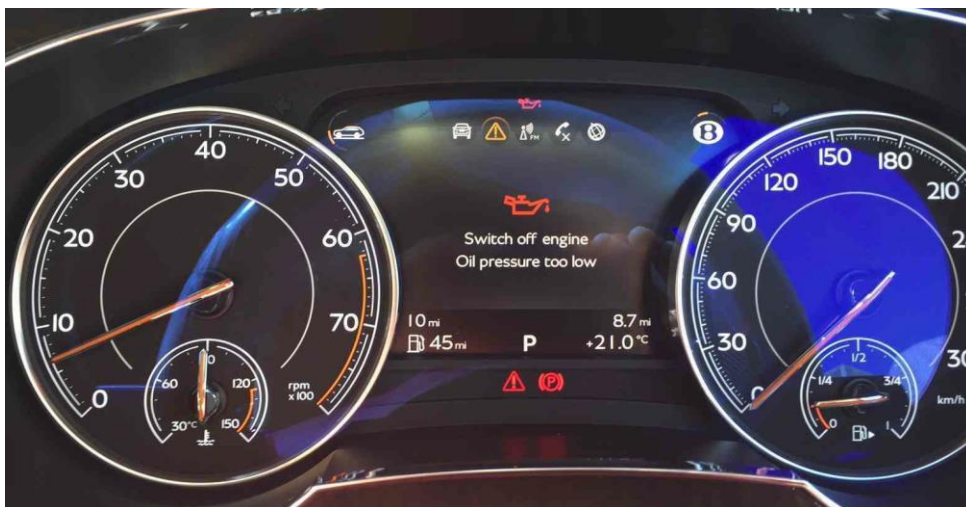
Low oil pressure warning illuminated in the driver instrument panel as shown in Figure 1 and event code P15AA00 is evident in one or both of the Engine Control Modules

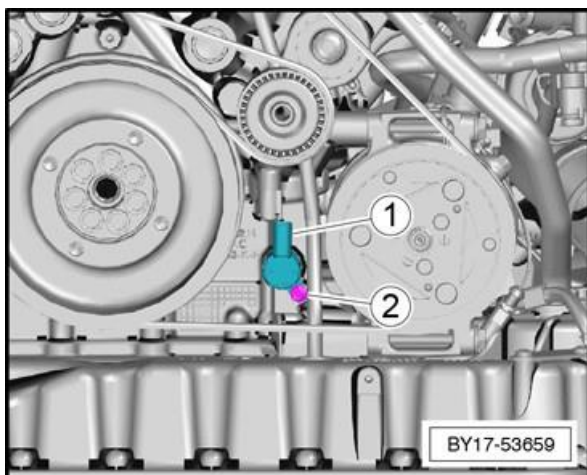
Figure 2

One failure mode for the oil control valve (item 1 Figure 2) results in low engine oil pressure when engine rpm is above 3500 and as with any low oil pressure occurrence the *Oil pressure too low* warning will be displayed in the driver instrument panel. Obviously this warning is legitimate and when it is the case that the oil control valve has failed then a replacement valve will rectify the issue, but other causes of low engine oil pressure will trigger this warning and these should not be overlooked. It is therefore critical that the root cause of the low oil pressure is identified.

In the event of *Oil pressure too low* warning displayed in the driver instrument panel as shown in Figure 1 and event code P15AA00 evident in one or both of the engine control modules then carry out the following checks to confirm the diagnosis is correct before considering replacing the oil control valve (item 1 Figure 2)

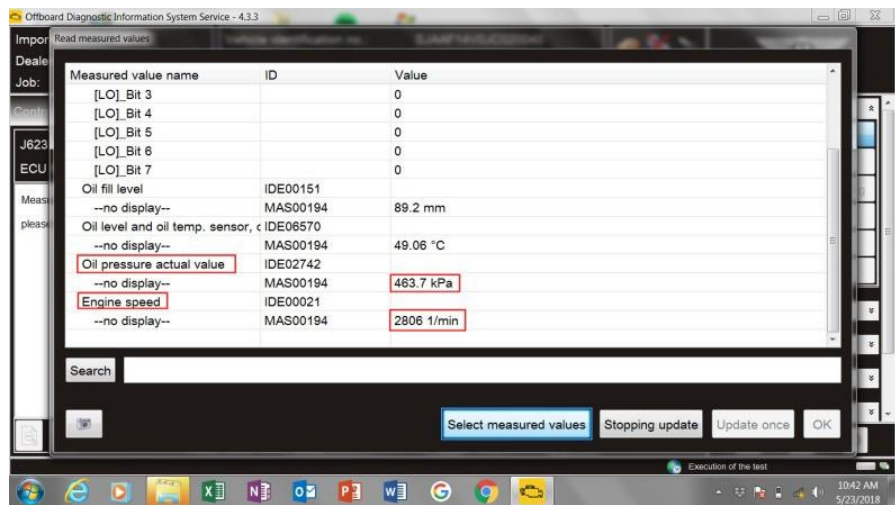
Figure 3 displays a 483kPa reading just below the 3500 rpm (2806 1/min) switching point and figure 4 displays the instant and substantial increase to 671kPa observed on a correctly functioning valve as engine rpm raises through 3500 (3525 1/min). Note: the pressure readings shown in the measured value are ‘absolute’

With the oil temperature in the sump below 100°C observe the oil pressure value change as the engine rpm increases through approximately 3500 rpm. If the oil pressure significantly rises as the engine rpm passes through 3500 rpm then the oil control valve is functioning correctly. If an instant raise is not seen and the *Oil pressure too low* warning is displayed in the driver instrument panel then replace the oil control valve with new part, part number 07P115243. Reference workshop manual Rep.Gr.17 - Valve for oil pressure control (N428) - To remove and fit.
