## Technical product information

| <b>Topic</b> | Emission control system lamp illuminated - DTC P044100 evident |
| <b>Brand</b> | Bentley |
| <b>Transaction No.</b> | 2053429/6 |

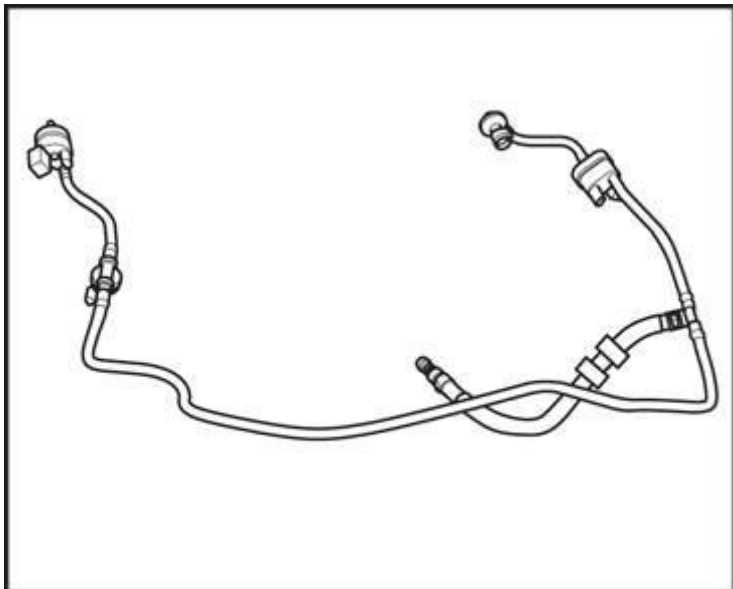
Figure 1

*NOTE: The solenoid valves are connected together with a hose, and have to be replaced as a unit as these solenoid valves and hoses are not supplied separately*

- 5) Replace the evaporative emission purge valve assembly (Figure 1) - Refer to repair manual Rep.Gr 20 - Evaporative emission purge valve - To remove and fit - pay attention to any debris/contamination falling from the ends of the line during disconnection, If contamination is found in the ends of the line or the engine ports please raise a DISS query

**IMPORTANT:** Please ensure the openings of the purge line assembly are fully sealed prior to returning back to Bentley Motors (Use the bungs which were fitted to new assembly for this purpose)
