## Technical product information

| <b>Topic</b> | DTC's P014800 and/or P008A00 - Rough running & potentially poor start up performance - MIL light on - Possible misfires |
| <b>Brand</b> | Bentley |
| <b>Transaction No.</b> | 2062016/5 |

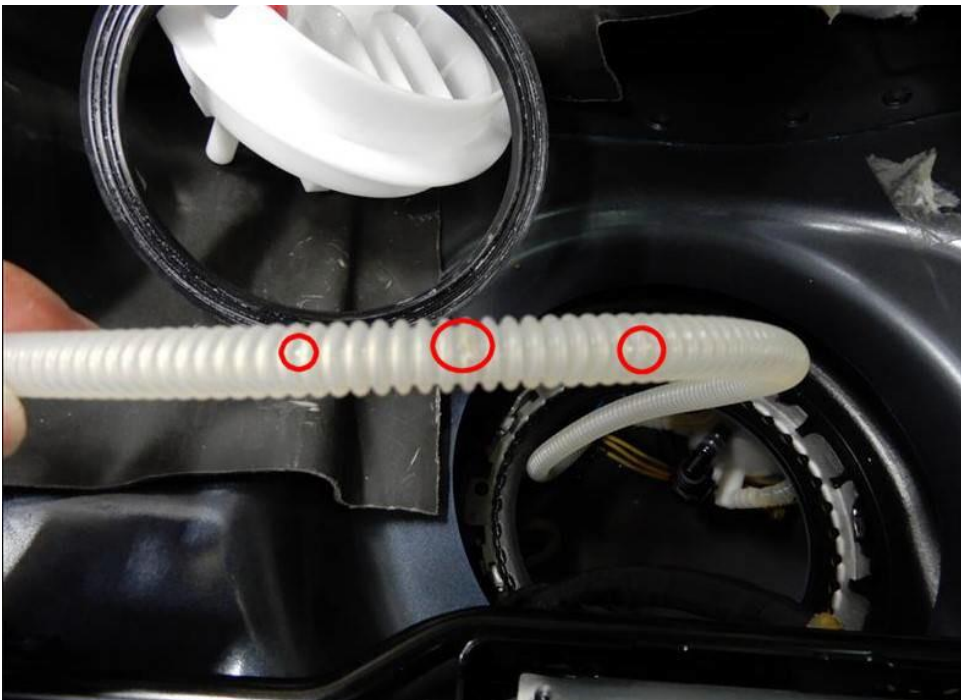
- Inspect the Fuel supply module and fuel filter fitment for detached hoses, damaged hoses and line and/or concerns with the module itself such as damage or leakage
- Figure 1 shows an example of a fuel tank internal hose with pin holes (circled)

9. Should any of the afore mentioned issues be evident the required parts should be replace as necessary  
 However in the event that all previous checks were to specification the operative should conduct step 10 to completion  
 10. Replace both bank 1 and 2 low pressure fuel rails, the fuel rails come complete with injectors (Figure 3).

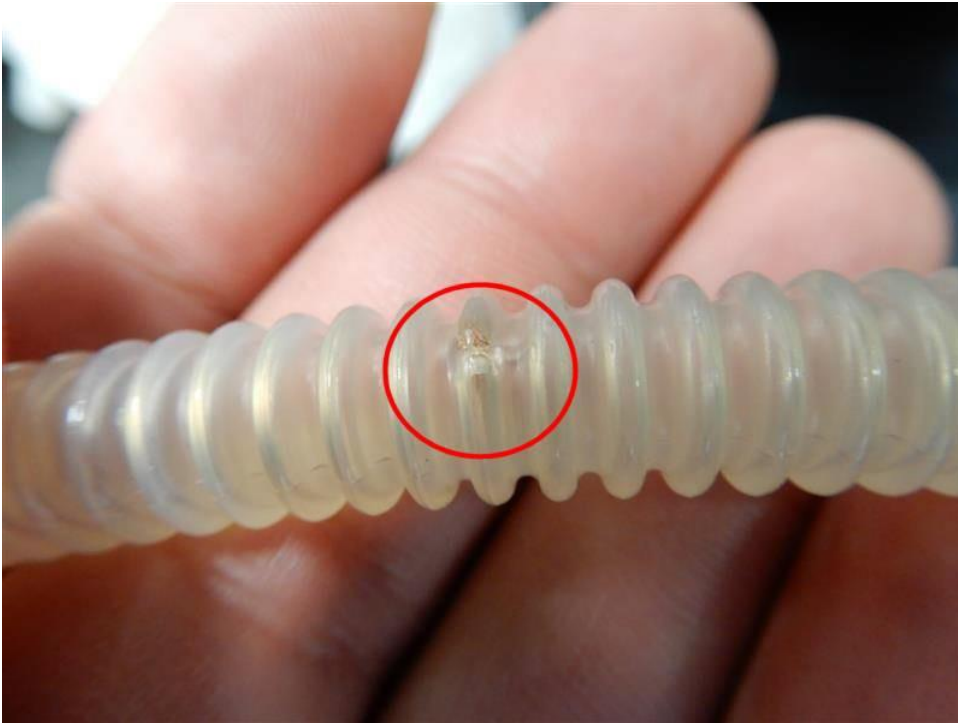
- Figure 2 shows a close up of the pin holes
