## Technical product information

| <b>Topic</b> | Air suspension warning light within the DIP - DTC's P089200 - C104707 - C103B13 - Evident within Address 74 | | |
| <b>Brand</b> | Bentley | | |
| <b>Transaction No.</b> | 2062259/6 | | |

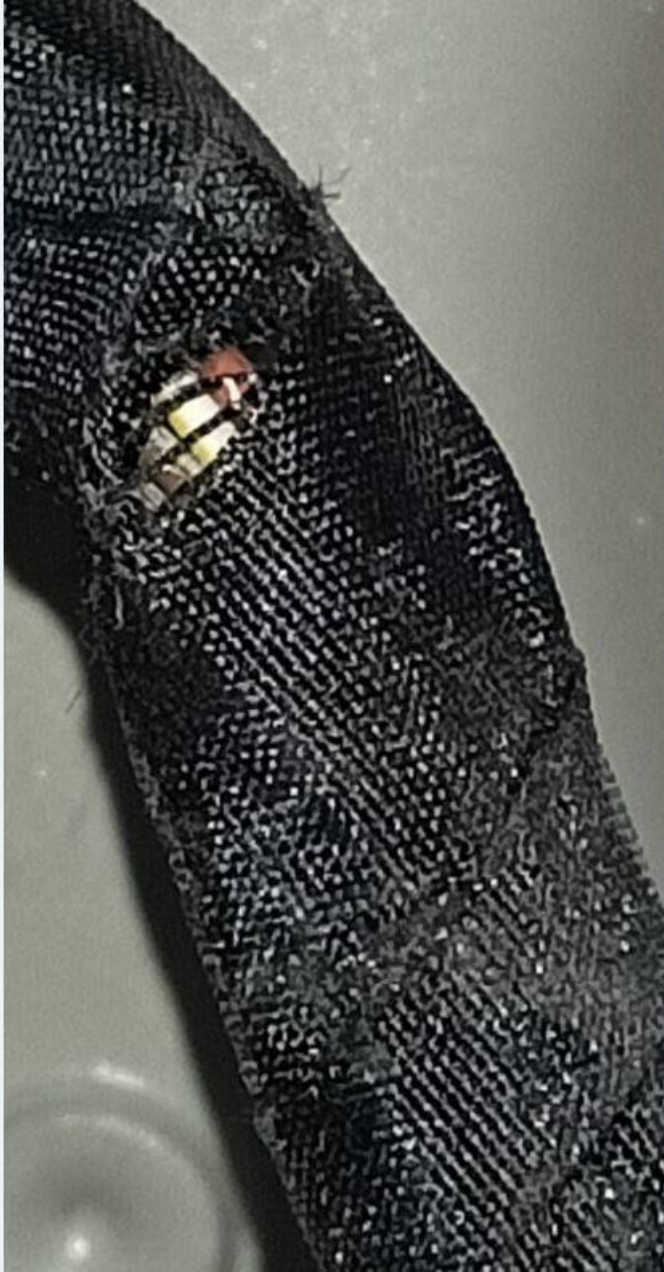
**TIP:** *Previous instances have highlighted the following after inspection:*

- Broken wires
- Kinked wiring
- Pin/s missing
- Pin/s broken
- Pin/s loose

NOTE: Refer to the example shown in Figure 1 of a damaged wiring harness

2) Repair any broken or damaged wires as per Rep.Gr 97
