## Technical product information

| <b>Topic</b> | Engine coolant - Overheat condition - Warning evident within the DIP - DTC's P2B6500 and P2B8600 are evident |
| <b>Brand</b> | Bentley |
| <b>Transaction No.</b> | 20666669/3 |

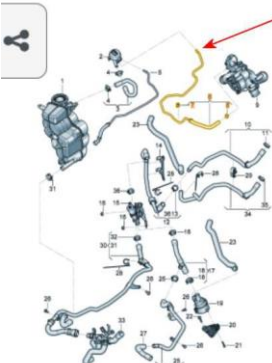
2) Referring to Figure 2 - Locate the vent hose shown (975 122 447H)

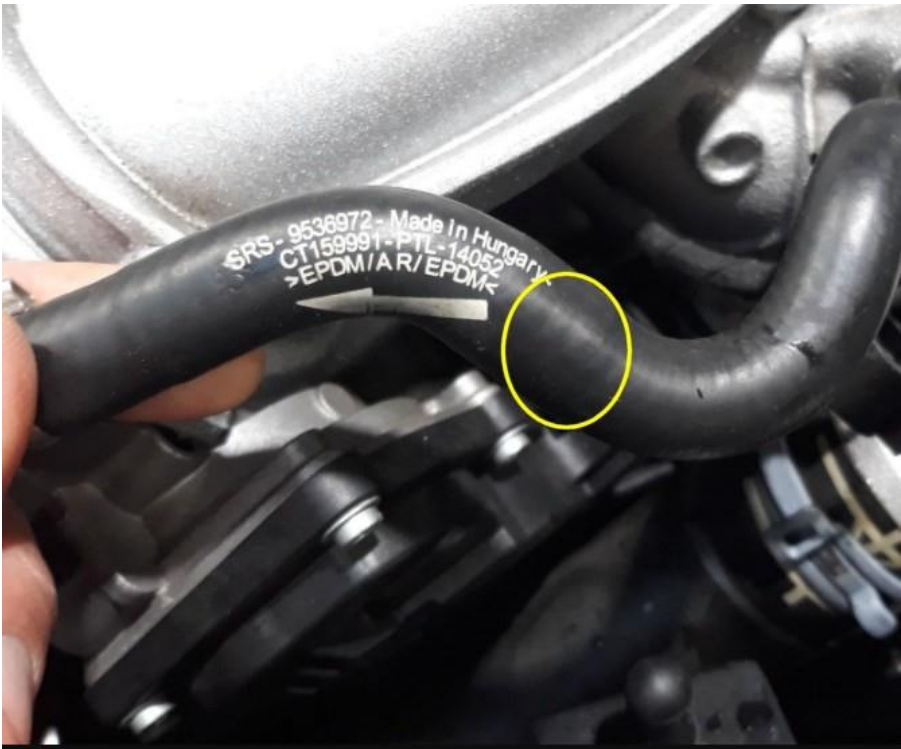
- The vent hose has an internal check valve, the valve is positioned within the vent hose at the location shown in Figure 3 (Circled)

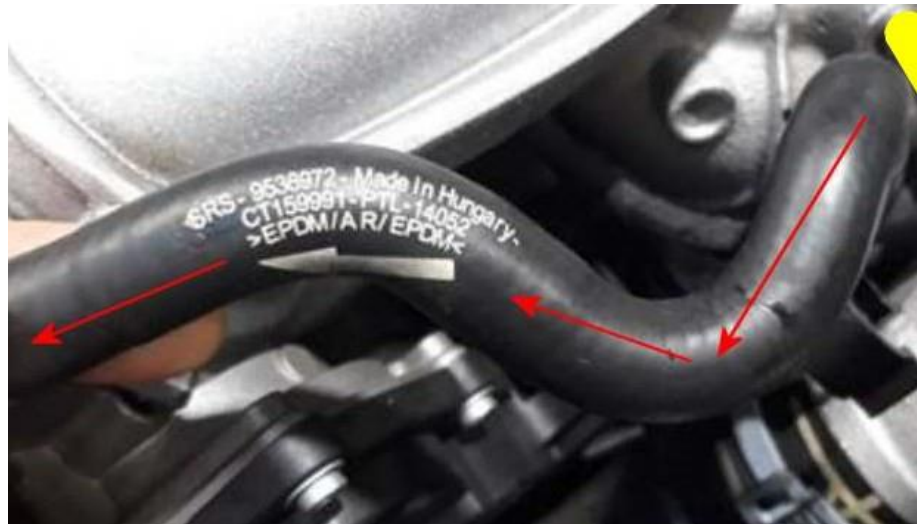
- Referring to Figure 4 - The coolant flows in the direction shown (Arrows) in the event the internal check valve is faulty the flow of the coolant will be restricted (***Causing the symptoms described within the customer findings/workshop findings section***)

4) Replace the vent line

- Once the vent line has been replaced - Referring to Rep.Gr 19 - Bleed the coolant system
- Erase all applicable DTC's
- Conduct a road test - On return check to confirm that no coolant related DTC's are evident

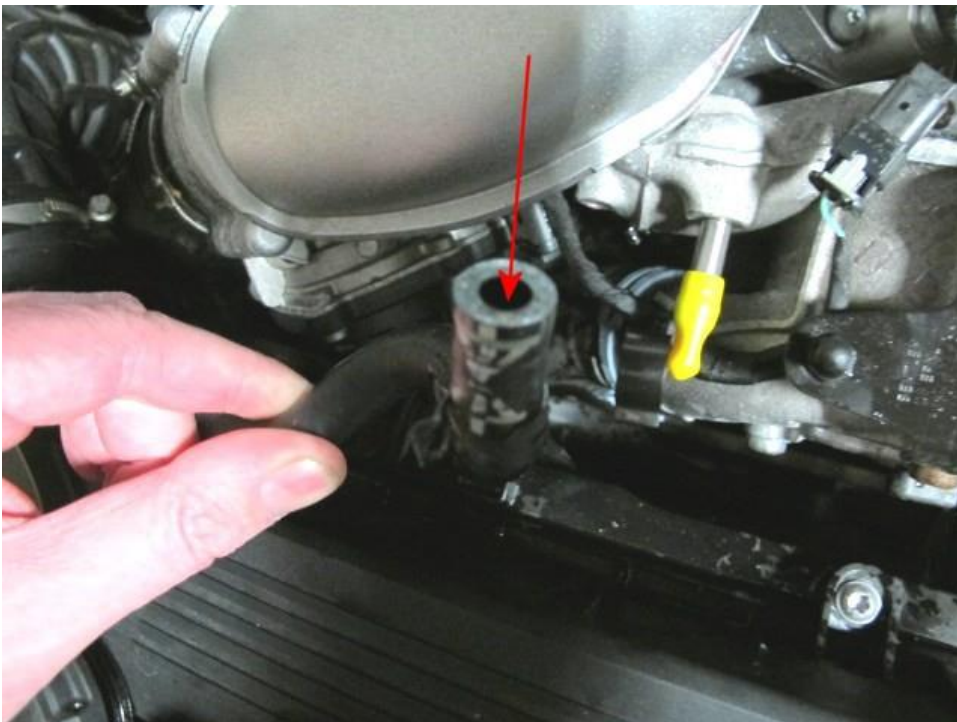
**Does the air flow through the vent line without any restrictions?**

5) Referring to Figure 8 - Apply light air pressure into hose (Arrow)
