# Technical product information

| Topic | Bentayga V8 Kovomo - Engine MIL light on - DTC "O2 Sensor Signals Swapped Bank 1 Sensor 2/ Bank 2 Sensor 2 |

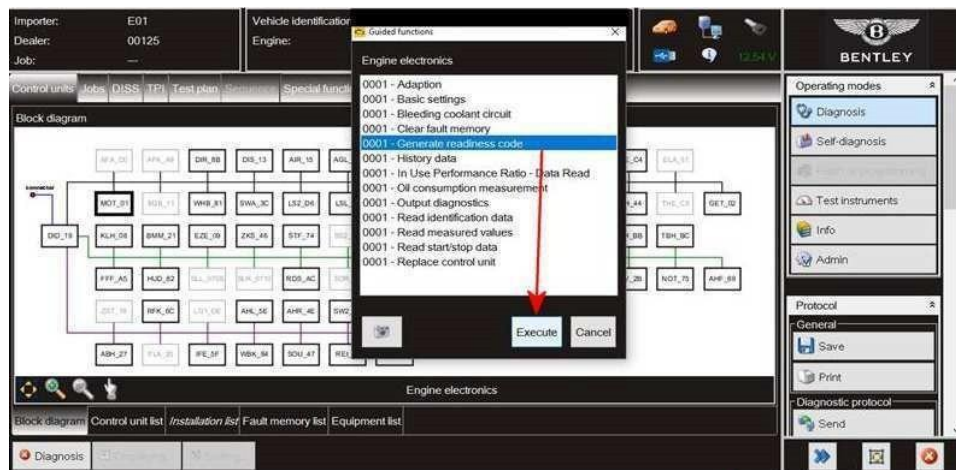
DTC P004100: "O2 Sensor Signals Swapped Bank 1 Sensor 2/ Bank 2 Sensor 2 is evident within address 0001 (Engine control unit) and MIL light active after attempting to conduct a readiness test

- Referring to Figure 1 - Select Guided functions from 01 - Engine Control Module 1
- Select Generate readiness code
- Select Execute and follow the readiness code procedure to completion as per all on screen prompts
