| <b>Topic</b> | New Continental GT and GTC - Window drop glass operation |
| <b>Transaction No.</b> | 2070497/4 |

Retailer glass reset procedure for GT/GTC

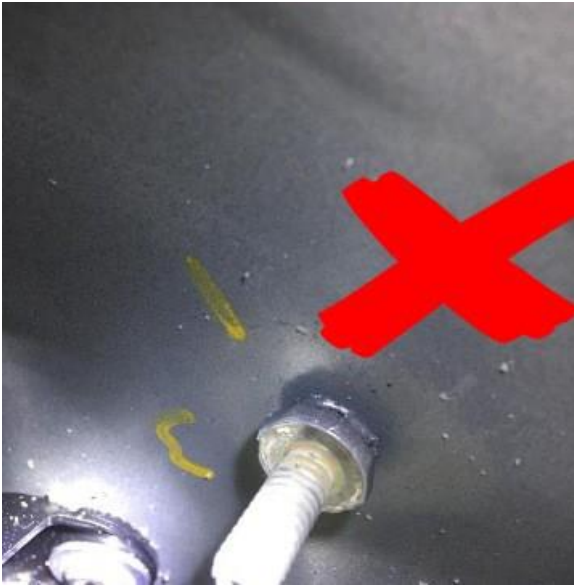
- 12) Check for cleanliness and security of both earth points
- Earth point 736 RHR and Earth point 738 LHR
  - Check for cleanliness and security of both earth points Figure 7 shows an example of a contaminated earth point (dirt/paint/debris)

- Remove any dirt/paint/debris from the earth points using suitable abrasives/wire brush ensuring no damage is caused to the earth stud threads as shown in Figure 8

- Secure the earth point fixings (9 Nm)

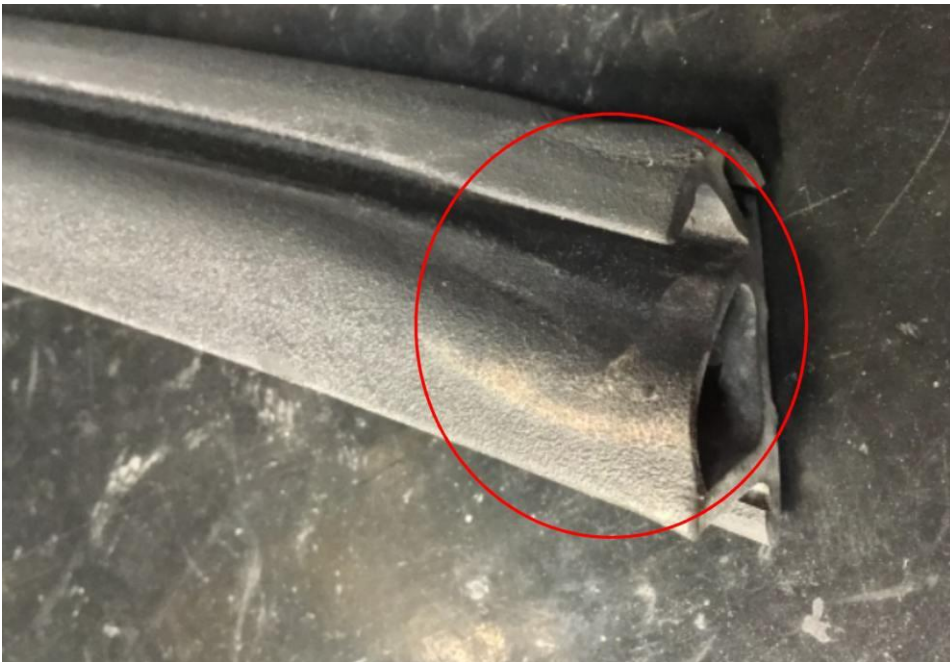
Figure 9

- Damage
- Splits
- Tears
- Misalignment
- Incorrectly fitted/located
- Drop glass seal deformation (see Figures 9 and 10 as examples)

NOTE: Any issues found with the window seals must be rectified before conducting the remaining steps

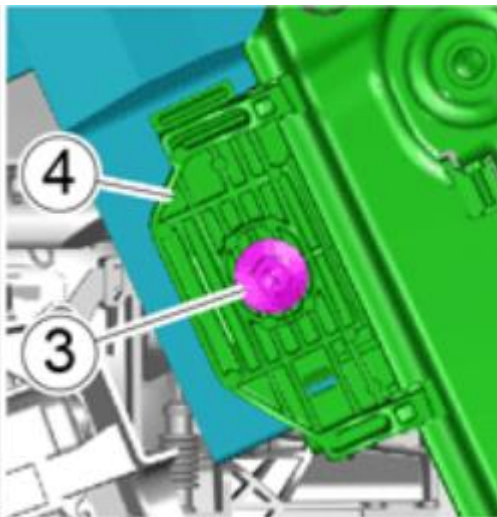
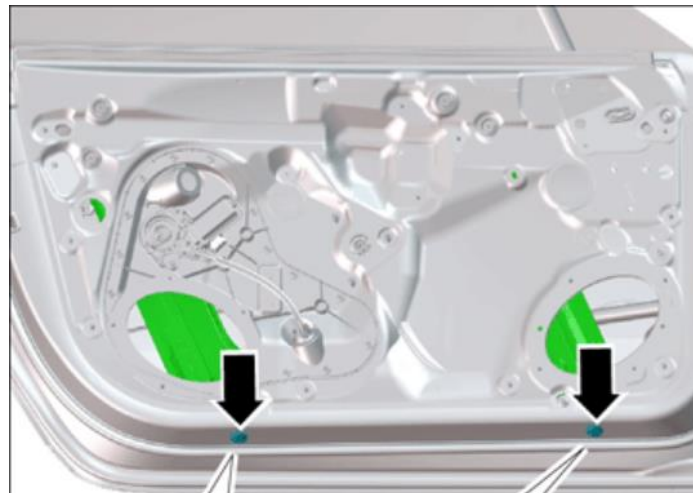
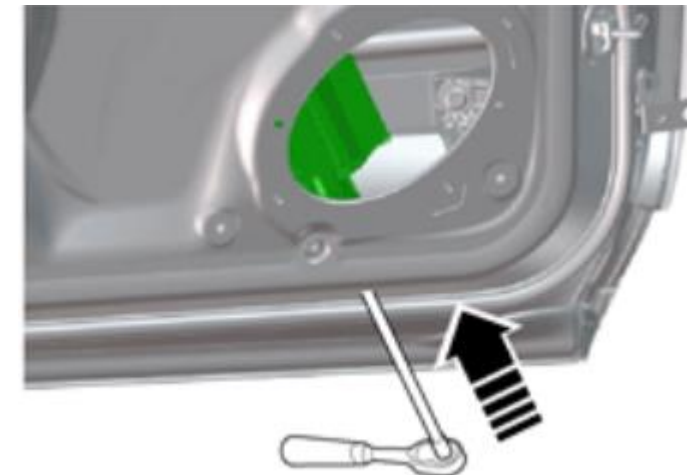
Example: Front drop glass Z axis not adjusted correctly. Bottom of tape was level with waist rail seal, after slackening pinch bolt (3 in bottom left image) front drop glass lowered 14mm to where pen marked line is.

Z-axis adjusters (bottom middle and right images) had not been used, pinch bolt had been slacked and glass lifted out of the regulator to achieve specification. This has a knock on effect of altering the 10mm division bar intrusion seen in previous slide as glass is loose and can be accidentally moved in X-axis.

This also creates a risk that the window will bottom out on the cant rail seals rather than the regulator bump stops meaning that the glass can raise further as the seals soften over time and affect end stop learning.

## Z-Axis height should only be adjusted by the 4mm Allen key adjusters as per ELSAPRO
