# Technical product information

| Topic | Flying Spur Hybrid - Engine warning lamp evident within the DIP - DTC U041100 and/or P0A2E00 is evident |

Flying Spur Hybrid - Engine warning lamp evident within the DIP - DTC U041100 and/or P0A2E00 is evident

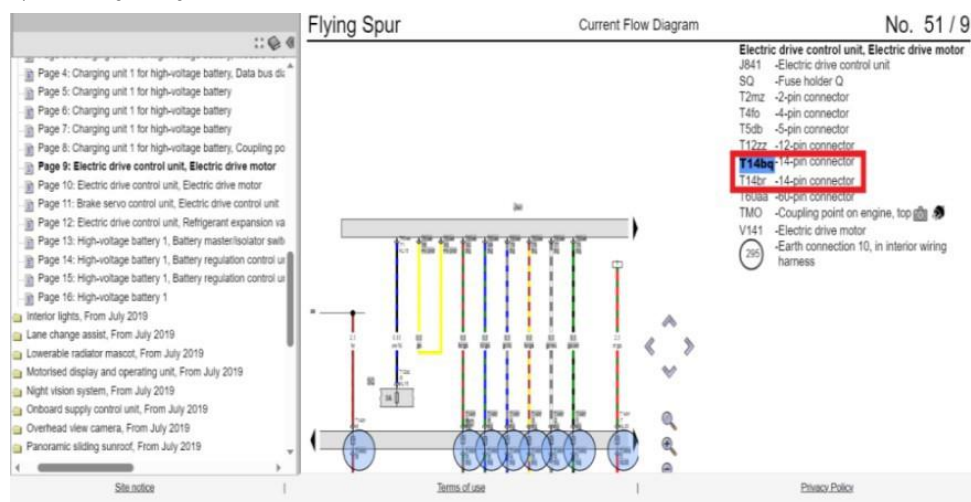
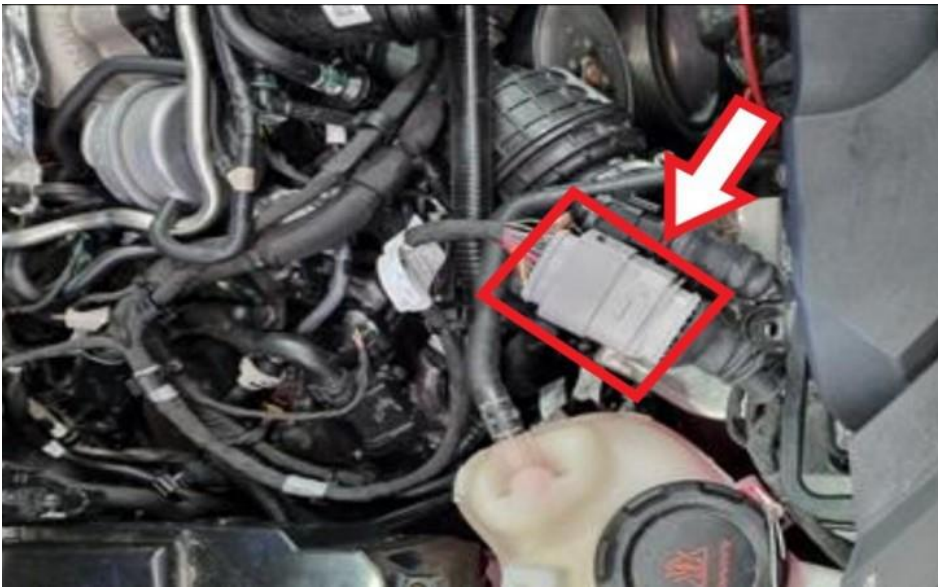
Figure 1

1) Referring to Figures 1 and 2 - Locate interconnect T14bq/br

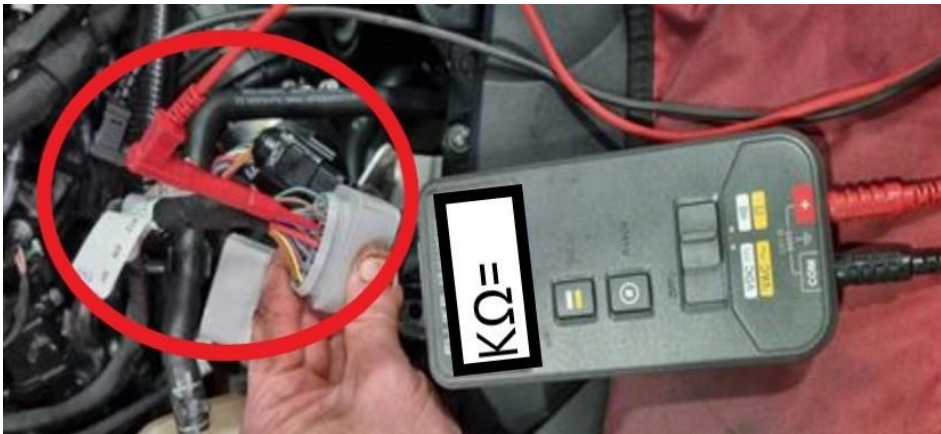
- 2) Referring to Figure 3 - Measure the resistance in  $K\Omega$  from the engine side of the connector T14bq (Terminal numbers 5 and 6)
- 3) Take a photograph of the resistance result in  $K\Omega$

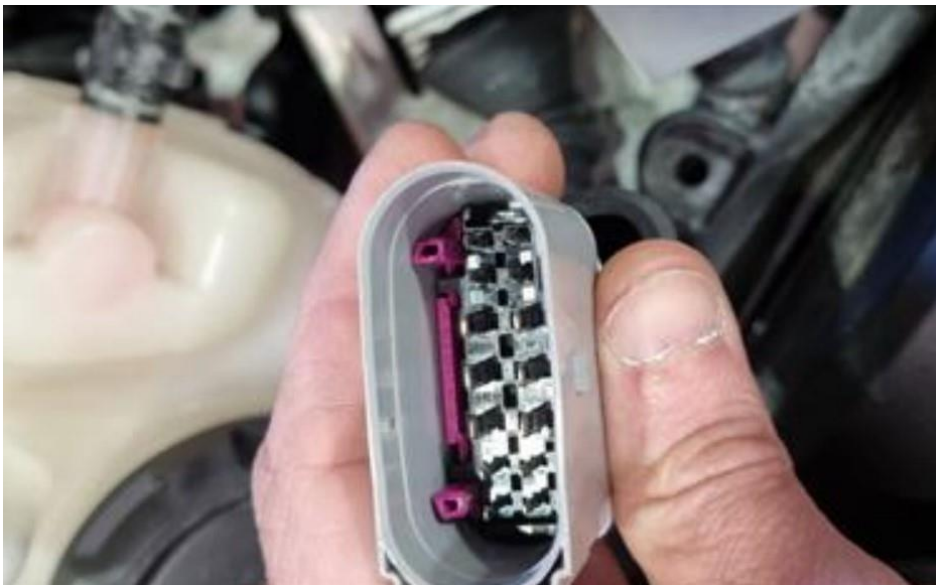
- 4) Referring to Figure 4 - Conduct a visual inspection of T14bq and T14br checking for any damaged pins/terminals
