## Technical product information

| <b>Topic</b> | V8 Kovomo - DTC - P025C00: Fuel Pump Module Control Circuit Low logged in 0001 |
| <b>Transaction No.</b> | 2071674/2 |

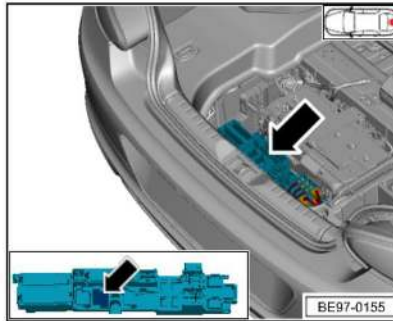
Figure 1

1) Referring to Figures 1 and 2 - Locate (J17) fuel pump relay

- Fuel pump relay -J17-

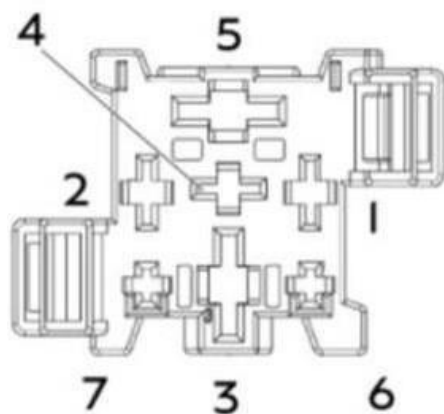
2) Referring to Figure 3 - Once removed conduct a visual check of all carrier terminals, check for the following:

- Loose terminals within the carrier
- Terminals which have spread (poor connection)
- Terminals which are damaged (poor connection)

4) Referring to Rep.Gr 97 - Wiring harness repairs - Renew the applicable terminals using the VAS 1978B wiring repair kit
