Subject: N232427260 - Customer Satisfaction Program  
Diesel Exhaust Fluid Control Module

Models: 2021 Chevrolet 6500XD Low Cab Forward (LCF)

# Customer Satisfaction Program

## N232427260 Diesel Exhaust Fluid Control Module

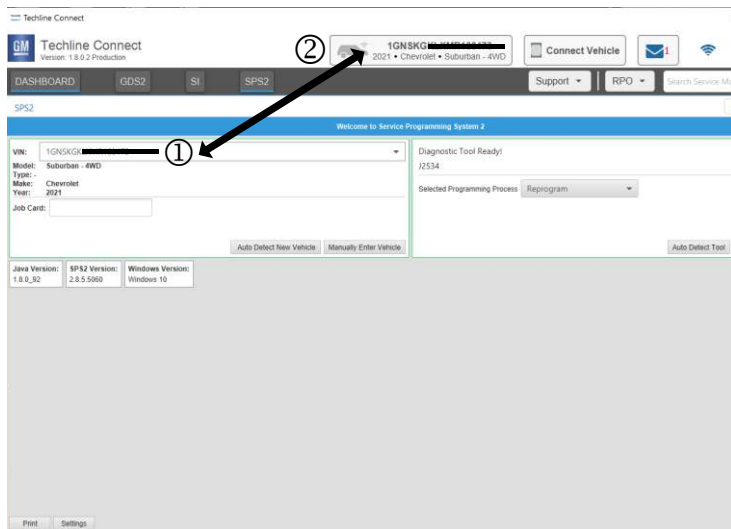
5743643

**Caution:** Be sure the VIN selected in the drop down menu (1) is the same as the vehicle connected (2) before beginning programming.

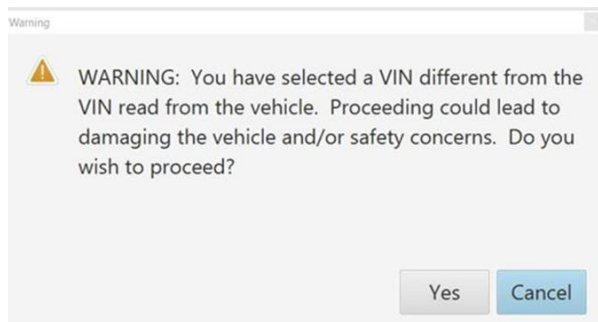
5877000

**Important:** If the vehicle VIN DOES NOT match, the message below will be shown.
