GLOBAL SAFETY FIELD INVESTIGATIONS  
DCS6718  
URGENT - DISTRIBUTE IMMEDIATELY

Subject: REVISION: N232421260-01 – Service Update  
False DTC Causing Unnecessary Battery Pack Replacements  
Revised Service Procedure

Models: 2020 – 2022 Chevrolet Bolt EV  
2022 Chevrolet Bolt EUV

# N232421260 False DTC Causing Unnecessary Battery Pack Replacements

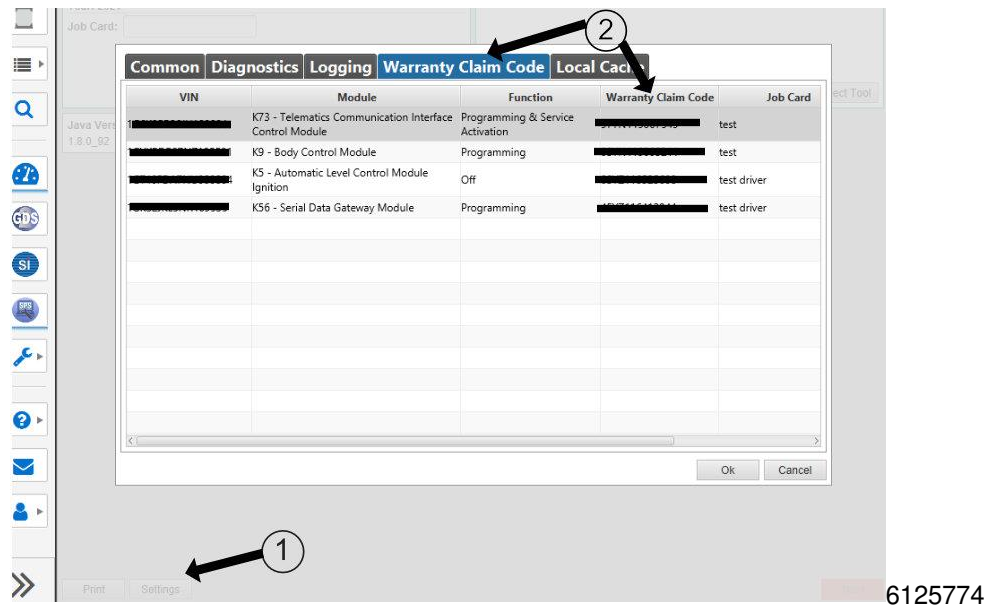
If the Warranty Claim Code was not recorded on the Job Card, the code can be retrieved in the SPS2 system as follows:

1. Open TLC on the computer used to program the vehicle.
2. Select and start SPS2.
3. Select Settings (1).
4. Select the Warranty Claim Code tab (2).

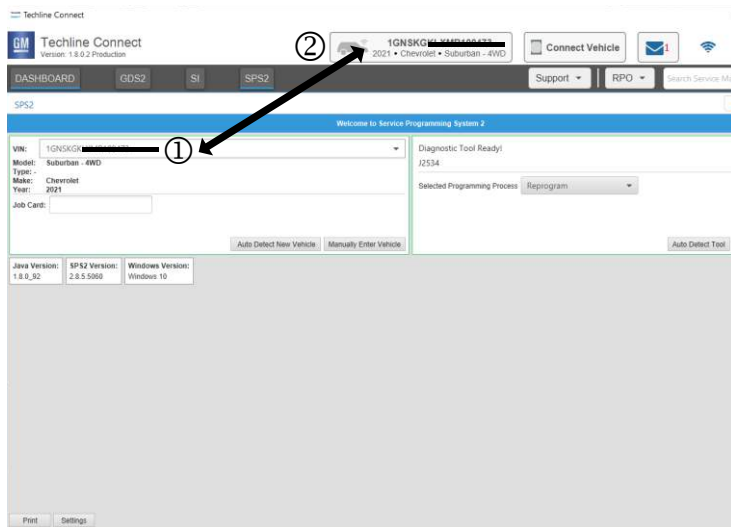
5743643

**Caution:** Be sure the VIN selected in the drop-down menu (1) is the same as the vehicle connected (2) before beginning programming.

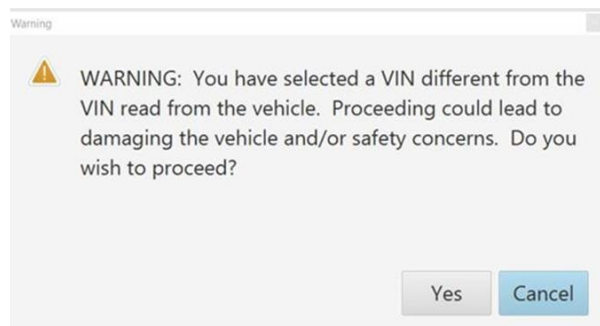
5877000

**Important:** If the vehicle VIN DOES NOT match, the message below will be shown.

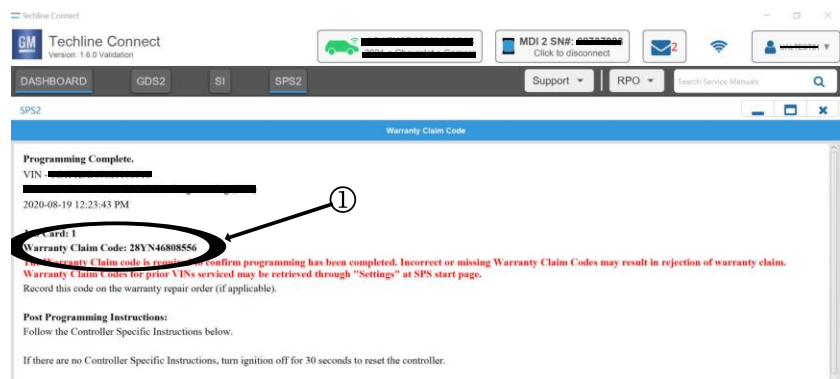
5644478

**Important:** To avoid warranty transaction rejections, you **MUST** record the warranty claim code provided on the Warranty Claim Code (WCC) screen shown above on the job card. Refer to callout 1 above for the location of the WCC on the screen.

3. Record SPS Warranty Claim Code on job card for warranty transaction submission.
