## TECHNICAL SERVICE BULLETIN

### Equipped With Hybrid Engine - Illuminated MIL With DTC P0A1E In The PCM

**23-2347**

09 November  
2023

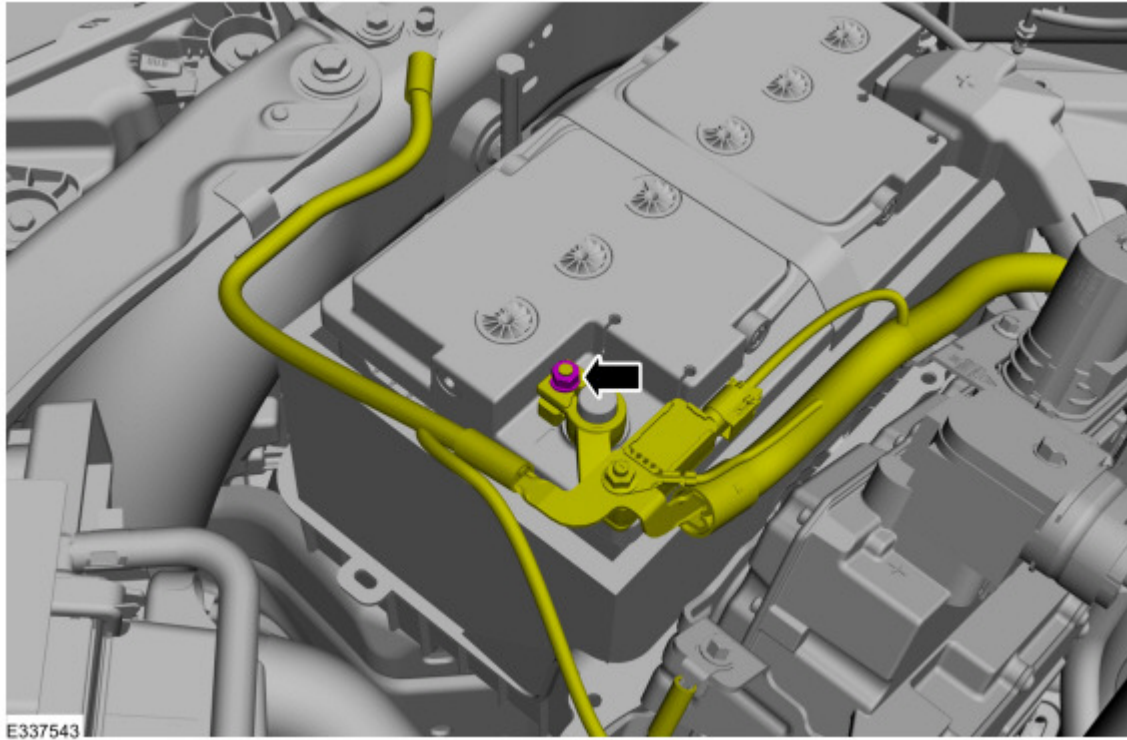
Figure 1 - F-150

- (1). Yes - repair is complete.
  - (2). No - proceed to Step 5.
5. At the 12V battery negative post, inspect the nut securing the battery monitoring sensor to the negative battery post. (Figures 1-2) If it is loose, tighten the nut to the specified tightening value. Refer to WSM, Section 414-01 Battery, Mounting and Cables, General Procedures, Battery Disconnect and Connect.

- For F-150 vehicles with a 3.5L hybrid engine, tighten to 55 lb.in (6.2 Nm).
  - For Explorer/Aviator vehicles equipped with a hybrid engine, tighten to 48 lb.in (5.4 Nm).

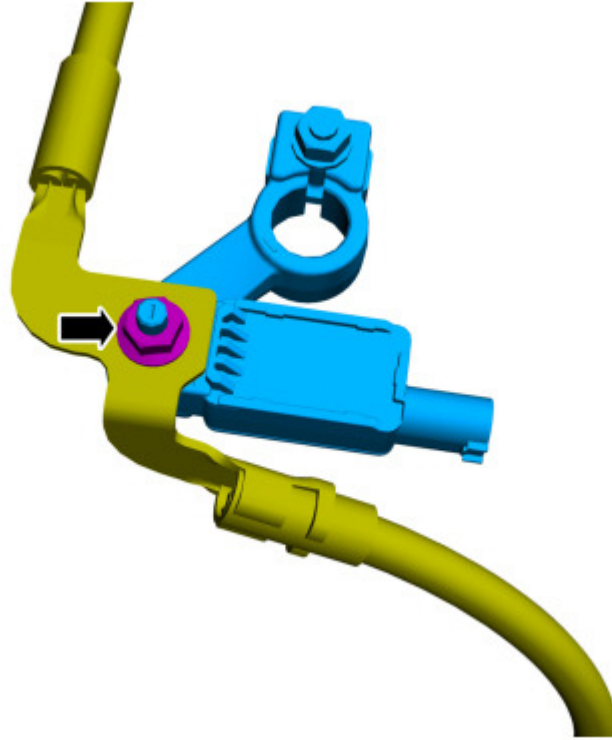
Figure 3

6. At the battery monitoring sensor, inspect the nut attaching the sensor to the ground cable. (Figure 3) If it is loose, tighten the nut to the specified tightening value. Refer to WSM, Section 414-01 Battery, Mounting and Cables, Removal and Installation, Battery Monitoring Sensor.

- For F-150 vehicles with a 3.5L hybrid engine, tighten to 97 lb.in (11 Nm).
- For Explorer/Aviator vehicles equipped with a hybrid engine, tighten to 80 lb.in (9 Nm).

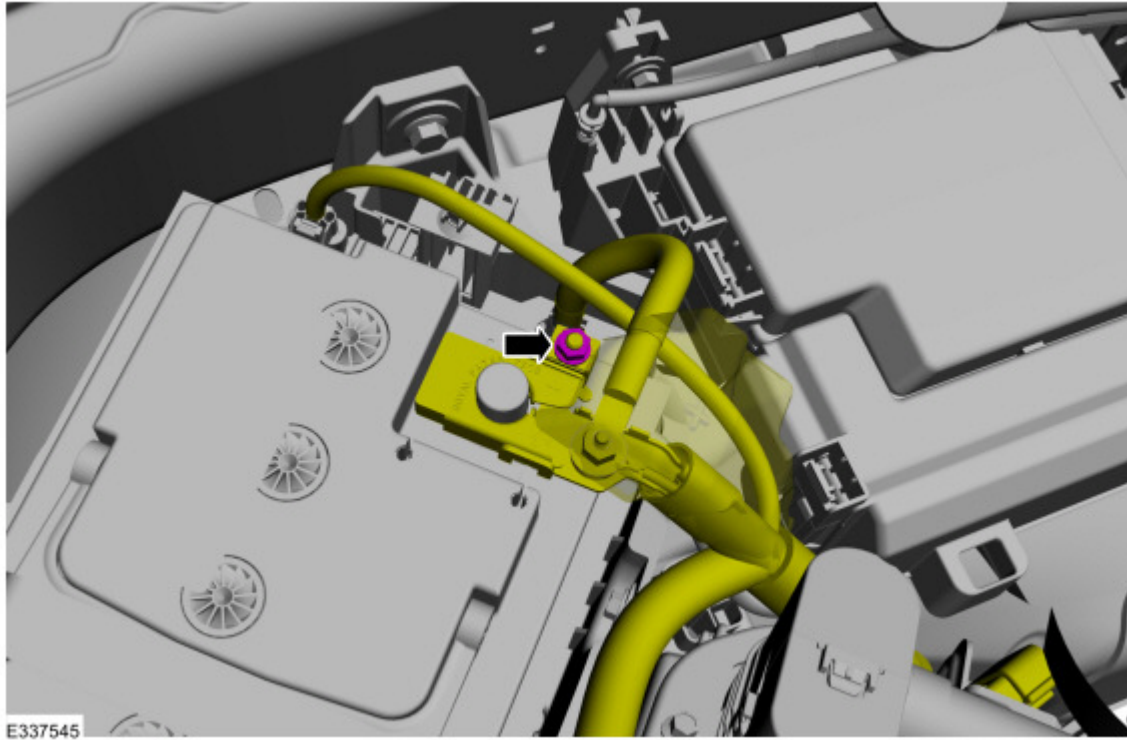
Figure 4 - F-150

7. At the 12V battery positive post, inspect the nut securing the positive battery cable to the post. (Figures 4-5) If it is loose, tighten the nut to the specified tightening value. Refer to WSM, Section 414-01 Battery, Mounting and Cables, General Procedures, Battery Disconnect and Connect.

- For F-150 vehicles with a 3.5L hybrid engine, tighten to 55 lb.in (6.2 Nm).
- For Explorer/Aviator vehicles equipped with a hybrid engine, tighten to 48 lb.in (5.4 Nm).

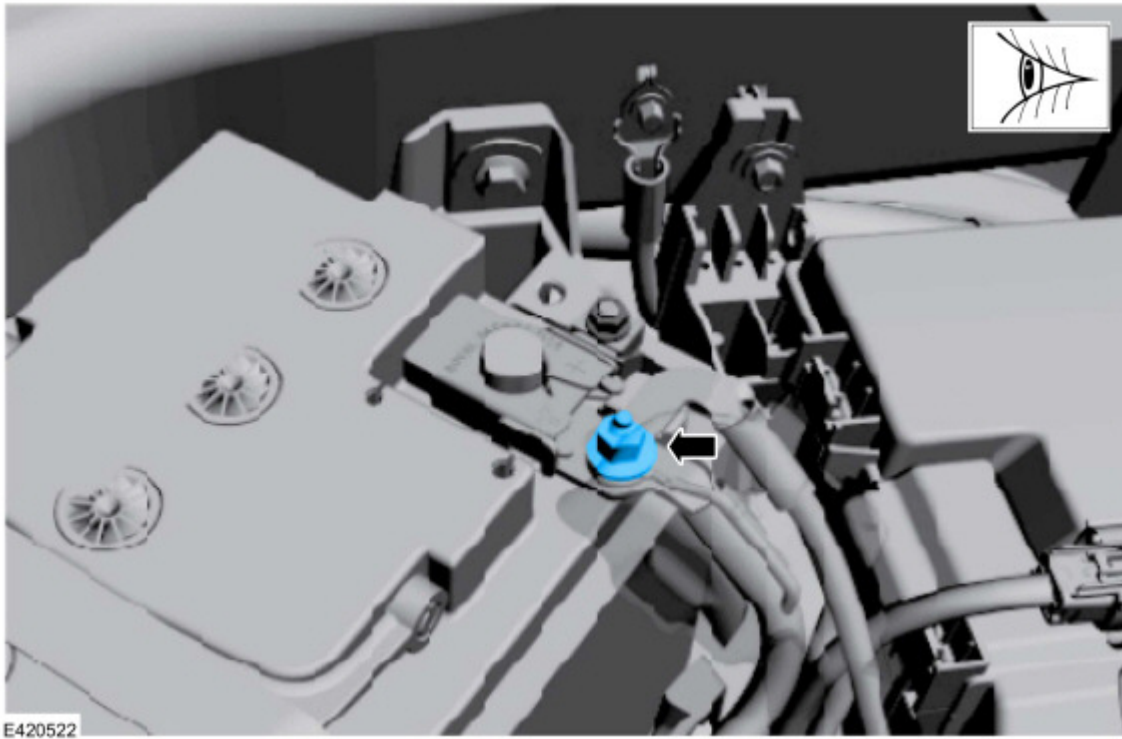
Figure 6 - F-150

8. At the 12V battery positive post, inspect the nut securing the positive cable eyelet lug. (Figures 6-7) If it is loose, tighten the nut to the specified tightening value. Refer to 414-01, Battery, Mounting and Mounting Cables, Removal and Installation.

- For F-150 vehicles with a 3.5L hybrid engine, tighten to 80 lb.in (9 Nm).
- For Explorer/Aviator vehicles equipped with a hybrid engine: 80 lb.in (9 Nm).

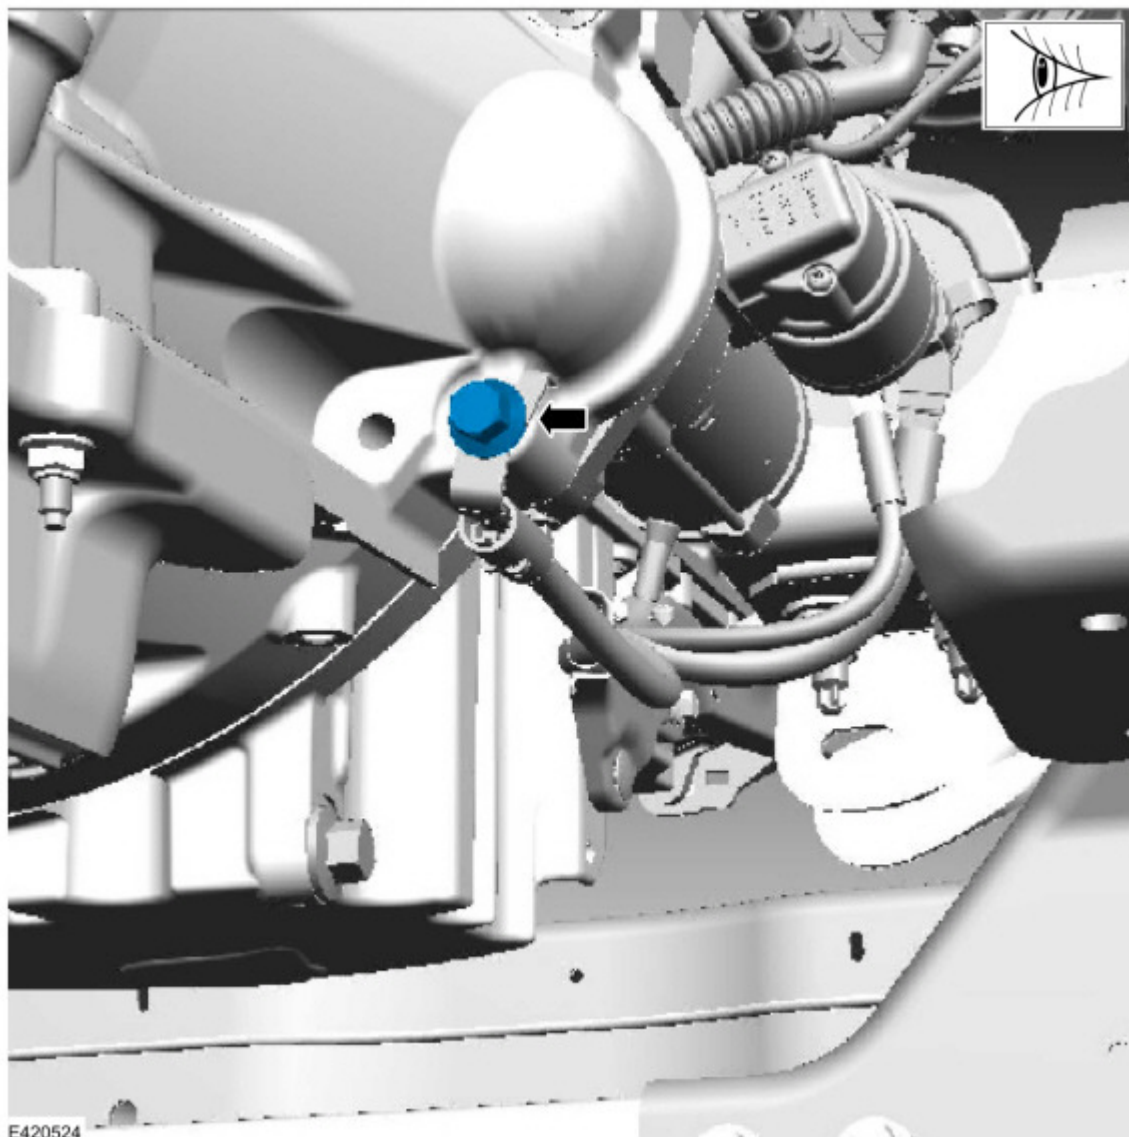
Figure 8 - F-150

9. Inspect engine ground G105. (Figures 8-10) Refer to Wiring Diagram, Cell 010, G105. If it is loose, tighten the bolt to the specified tightening value.

- For F-150 vehicles with a 3.5L hybrid engine, tighten to 35 lb.ft (48 Nm).
- For Explorer/Aviator vehicles equipped with a hybrid engine, tighten to 106 lb.in (12 Nm).
