# Technical Service Bulletin

## 01 MIL on, Whistling noise, leaking air Bank 2 - DTC P2ADF00, Engine Crankcase breather

01 23 92 2071318/4 November 6, 2023. Supersedes Technical Service Bulletin Group 01 number 23-87 dated October 23, 2023, for reasons listed below.

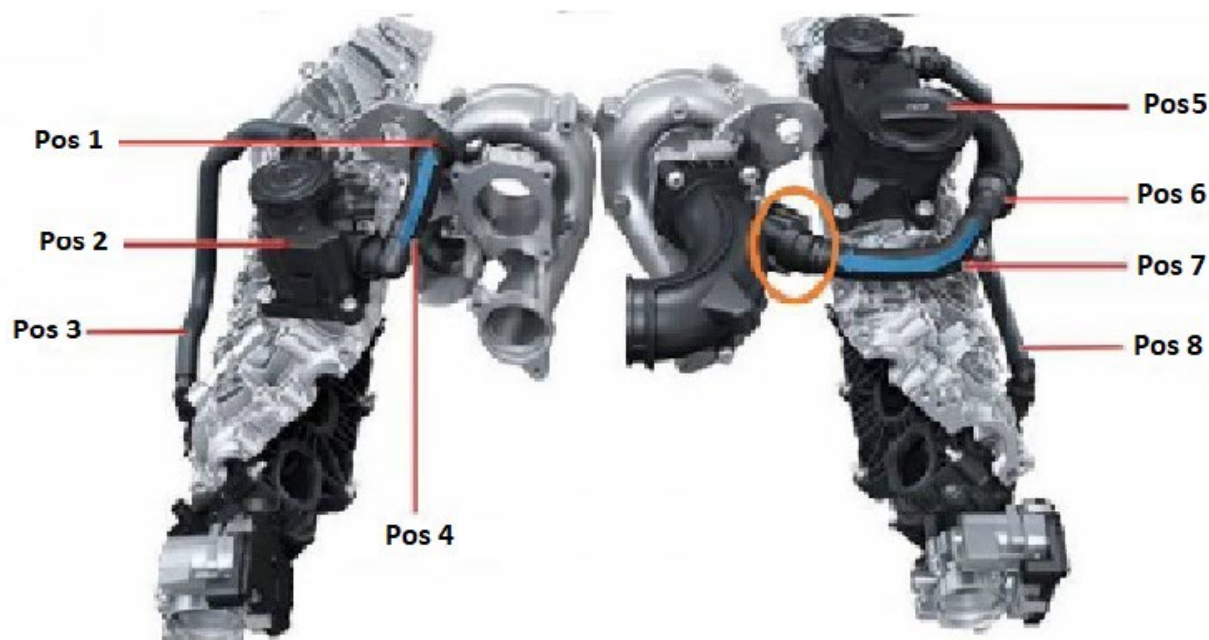
- Item 1: Non-return valve
- Item 2: Oil separator for bank 1
- Item 3 Part load breather line for bank 1
- Item 4: Full load breather line for bank 1
- Item 5: Oil separator for bank 2
- Item 6: Non-return valve *(Not applicable for engine codes CWWB, and DWKA, because Non-return valve is integrated into the intake manifold)*
- **Item 7: Full load breather line for bank 2**
- Item 8: Part load breather line

In this case, replace the full load breather line for cylinder bank 2.

1. Do not replace the oil separator for bank 1 or bank 2 or the part load breather lines.
  - a. Please refer to image of the crankcase from the Self Study Program 920493 as a guide.
