# Technical Service Bulletin

## 34 Function restriction with event memory entry P071800 - P276800 (symptom 20736 - 20737)

34 23 64 2067653/4 November 1, 2023. Supersedes Technical Service Bulletin Group 34 number 23-62 dated January 26, 2023 for reasons listed below.

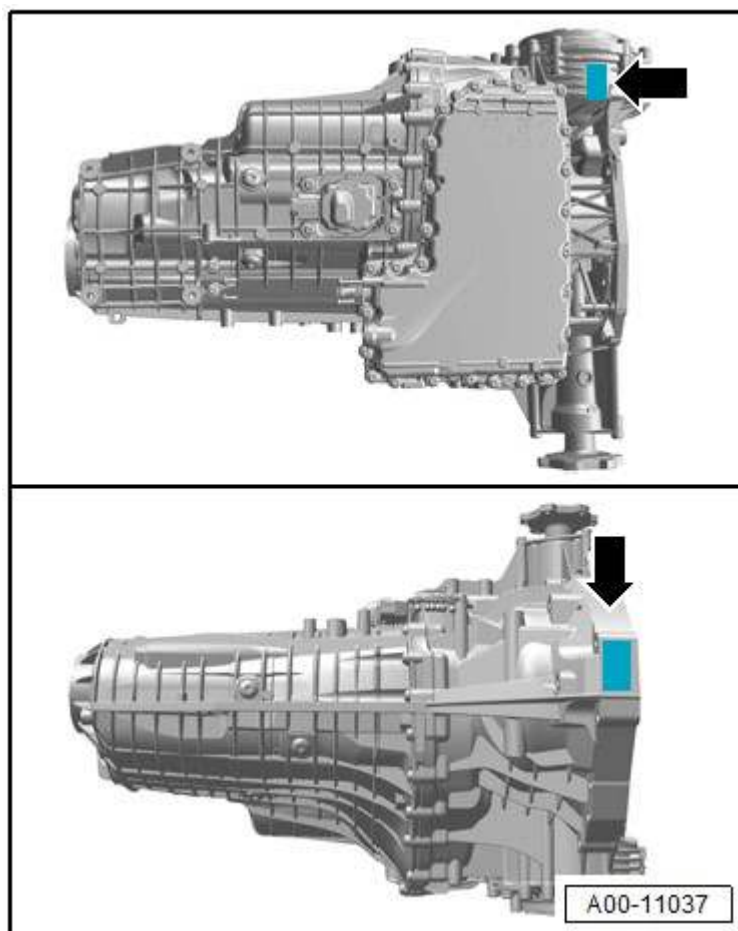
- **First determine if the Transmission was built within the date range of June 15, 2020, and May 31, 2022.**
- Check one of the transmission data stamps which are located on the bottom of the front differential and the top of the bell housing (Figure 1).

**Figure 1.** Locations of data stampings.
