# Technical Service Bulletin

## 90 Error message "CBR1021E: Can't parse Request. (cpngw)" when adapting control units, keys or immobilizer, B201700

90 23 50 2072005/1 November 6, 2023.

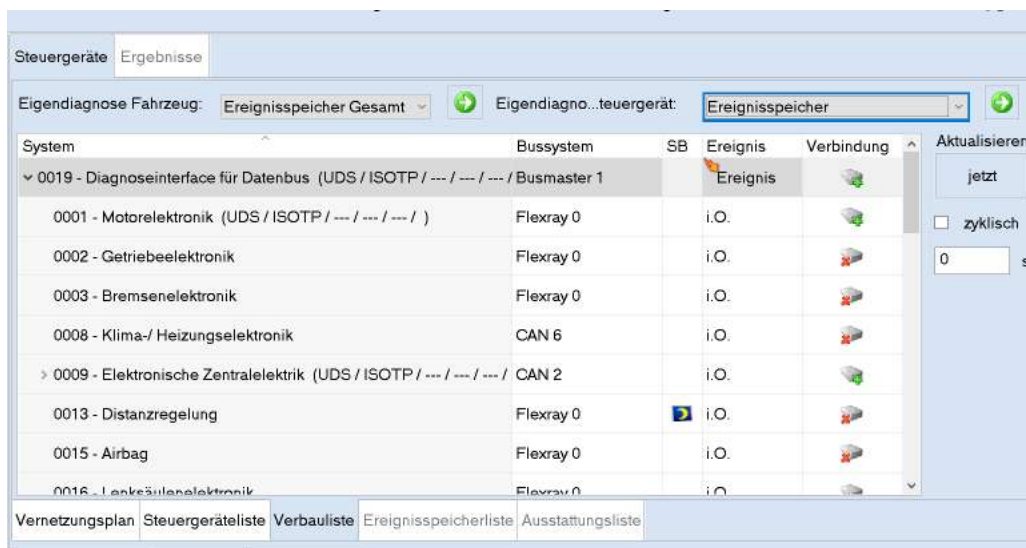
**Figure 1. Self Diagnosis Identification**

1. Scan the vehicle using self-diagnosis to determine if the VIN number is readable in the extended identification in the Gateway (address word 0019). To do so, proceed as follows:
  - a. Open the vehicle self-diagnosis.
  - b. Select **"0019 – Data Bus On Board Diagnostic Interface"** and then use the drop-down menu (top right) to select **Identification**. (Figure 1).

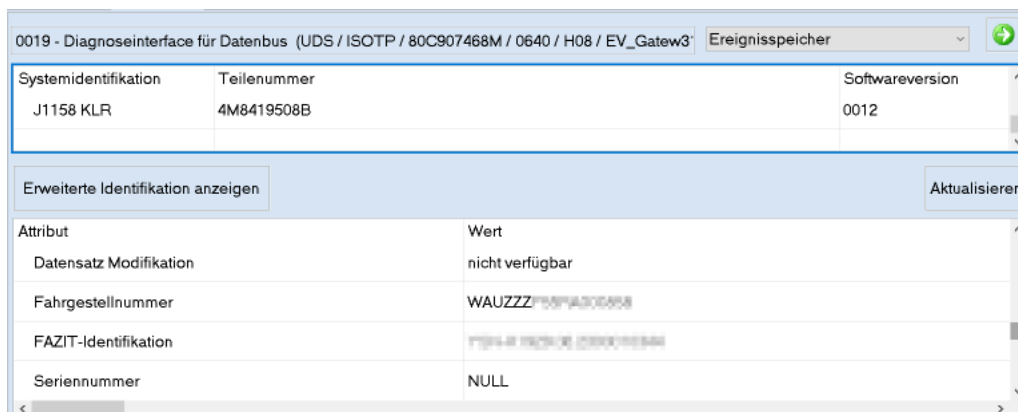
**Figure 2. VIN Number**

2. Open the identification for the Data Bus On Board Diagnostic Interface with the green arrow.
  - a. Scroll down to the VIN number. (Figure 2).

3. If the VIN number displayed is partly made up of symbols, this TSB applies. In this case, replace the Gateway control module, J533.
4. If the VIN number displayed is correct for the vehicle, this TSB does not apply. Replacing the data bus diagnostic interface will not fix the problem. Proceed with standard diagnosis.
