# Technical Service Bulletin

**97 Message "Drive system: fault. Limited performance" DTC P048000, P048100, U063300, P069400**  
97 23 03 2072000/1 November 17, 2023.

| Model(s) | Year | VIN Range | Vehicle-Specific Equipment |
|---|---|---|---|
| Q7, SQ7, Q8, SQ8, and RS Q8 | 2020 – 2024 | All | Not Applicable |

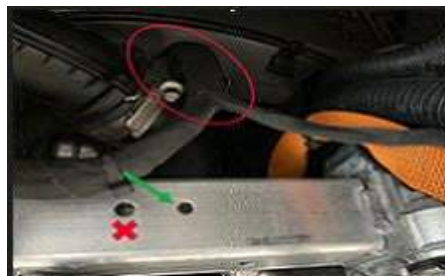
The wiring harness for the radiator fans may be loose at an attachment point and chafe against adjacent components.

**Figure 1:** Secure fan harness to green arrow

1. If the wiring harness is damaged in the area circled in red (refer to photo), repair it using wiring harness repair set **VAS 1978 B/C**.
2. Then secure the wiring harness at the lower longitudinal member (green arrow Figure 1).
3. Ensure there is sufficient clearance so that the wiring harness does not contact other components.

The wiring harness must be secured at the smaller hole on the right as the clip will not hold permanently in the larger hole on the left.
