Preliminary Information

PIP4964E SES Light With A P2097 Or P2099

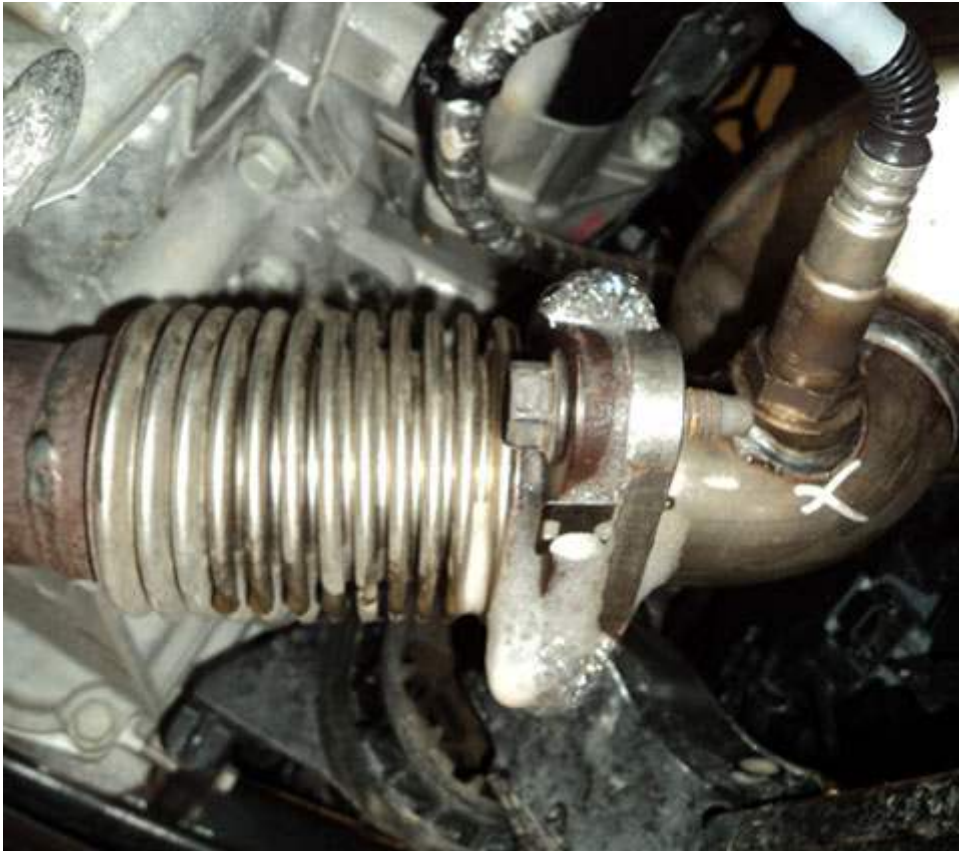
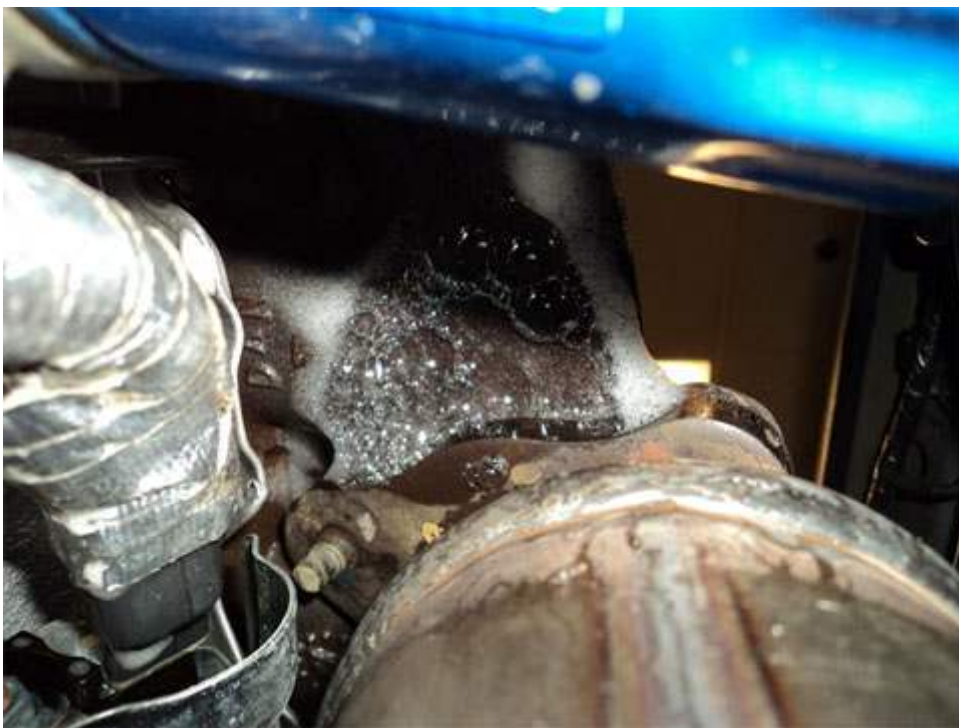
Apply a soapy solution to the gasket areas and the O2 boss.

Leaks in these areas that will cause the code will be larger bubbles.

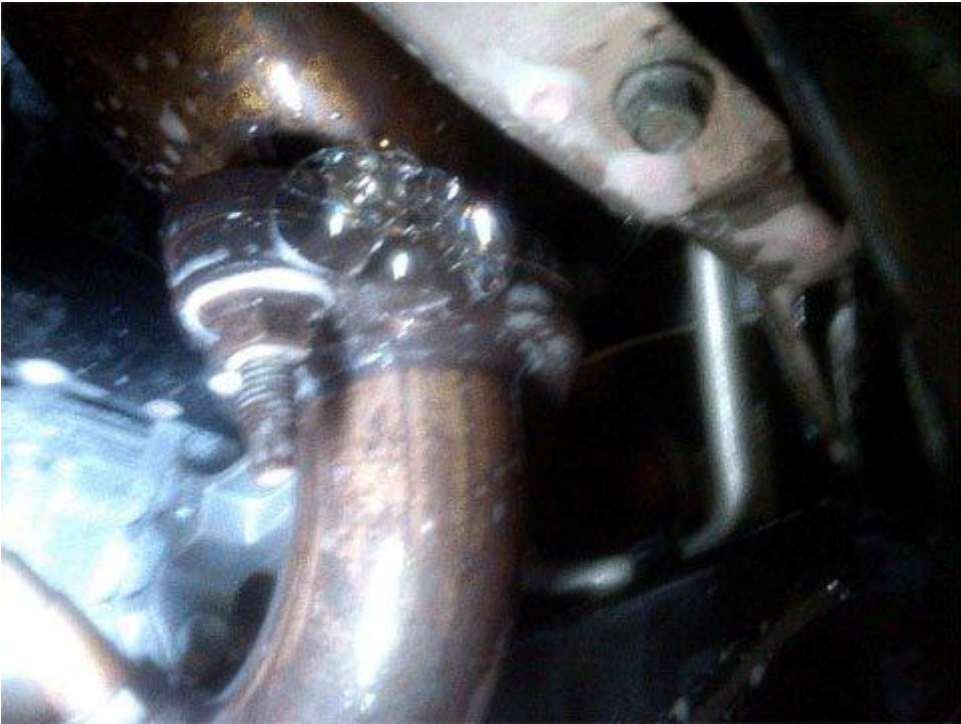
**Foam leaks are considered normal.**

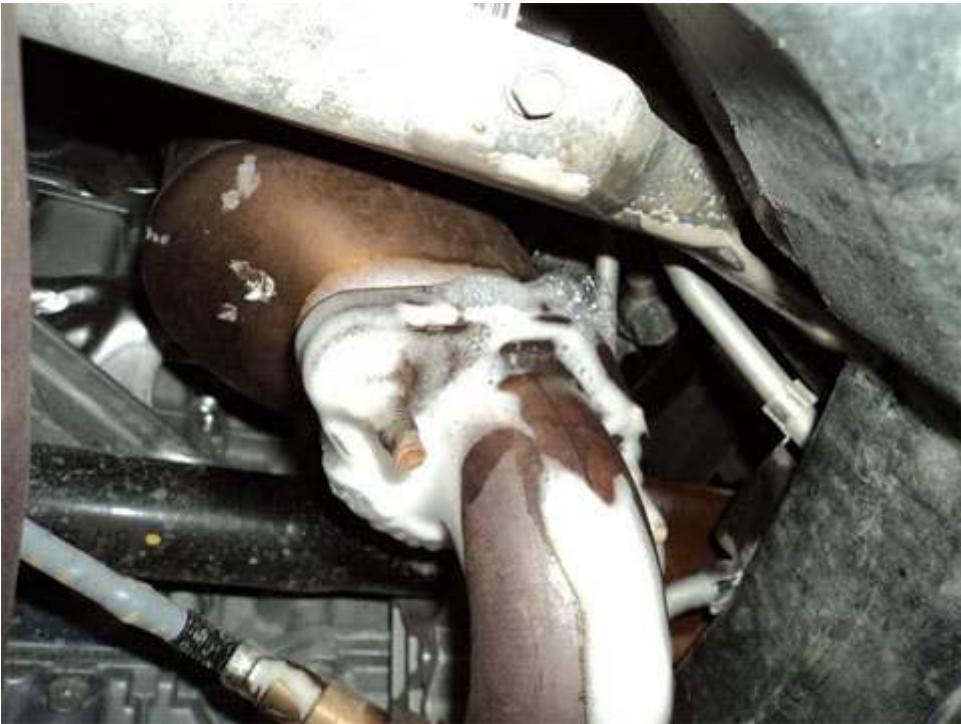
**DO NOT APPLY FULL SHOP AIR as converter and engine damage can result.**

**If available CAC leak tester J-46091-1 and adapter can be used with a modification using wire ties to hold it to the pipe.**

**Or GE-52250 - Tool For Leak Testing Charge Air Cooler / Turbo System will work also.**
