## TECHNICAL SERVICE BULLETIN

### 400 Watt DC/AC Inverter System Inoperative With B1330:9A In The BCM

**23-2367**

Ford  
2021-2023 F-150

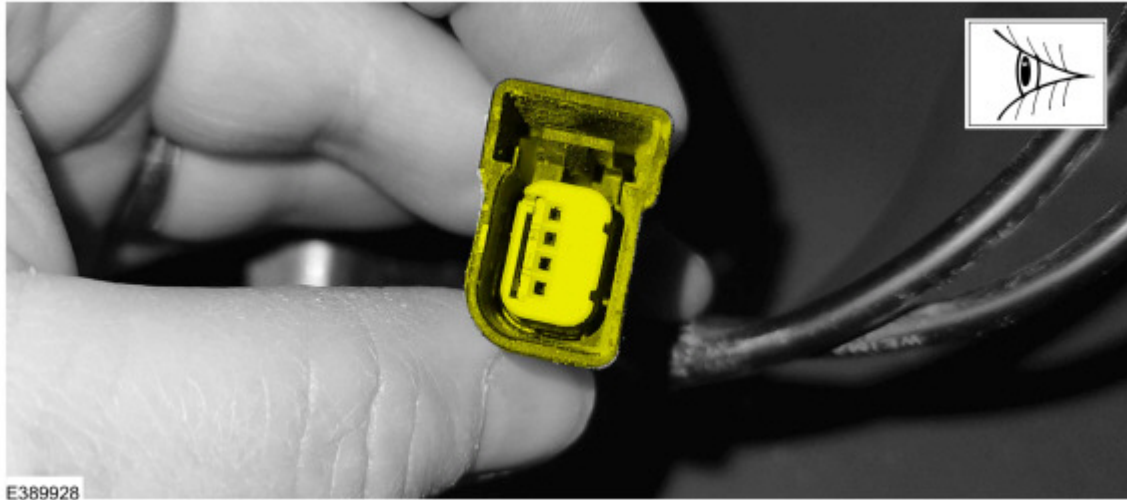
2. Using a suitable tool, carefully cut and remove the pickup bed AC power outlet socket harness retainer from the pickup bed AC power outlet socket harness. Discard the retainer.
  3. Inspect connector C4628 for the presence of corrosion, dirt and/or damage. Is corrosion, dirt and/or damage present in connector C4628? (Figure 2)
- Figure 2

- (1). Yes - replace the pickup bed AC power outlet socket assembly. Refer to Workshop Manual (WSM), Section 414-05. Replace the body side harness assembly (13A409) of connector C4628. Proceed to Step 4.
- (2). No - proceed to Step 4.
- 4.** Install a new pickup bed AC power outlet socket harness retainer 4.3 in. (110 mm) from the back of the pickup bed power outlet harness connector. If the pickup bed AC power outlet socket has been replaced, remove and discard the factory-installed harness retainer and install the new harness retainer. (Figure 3)

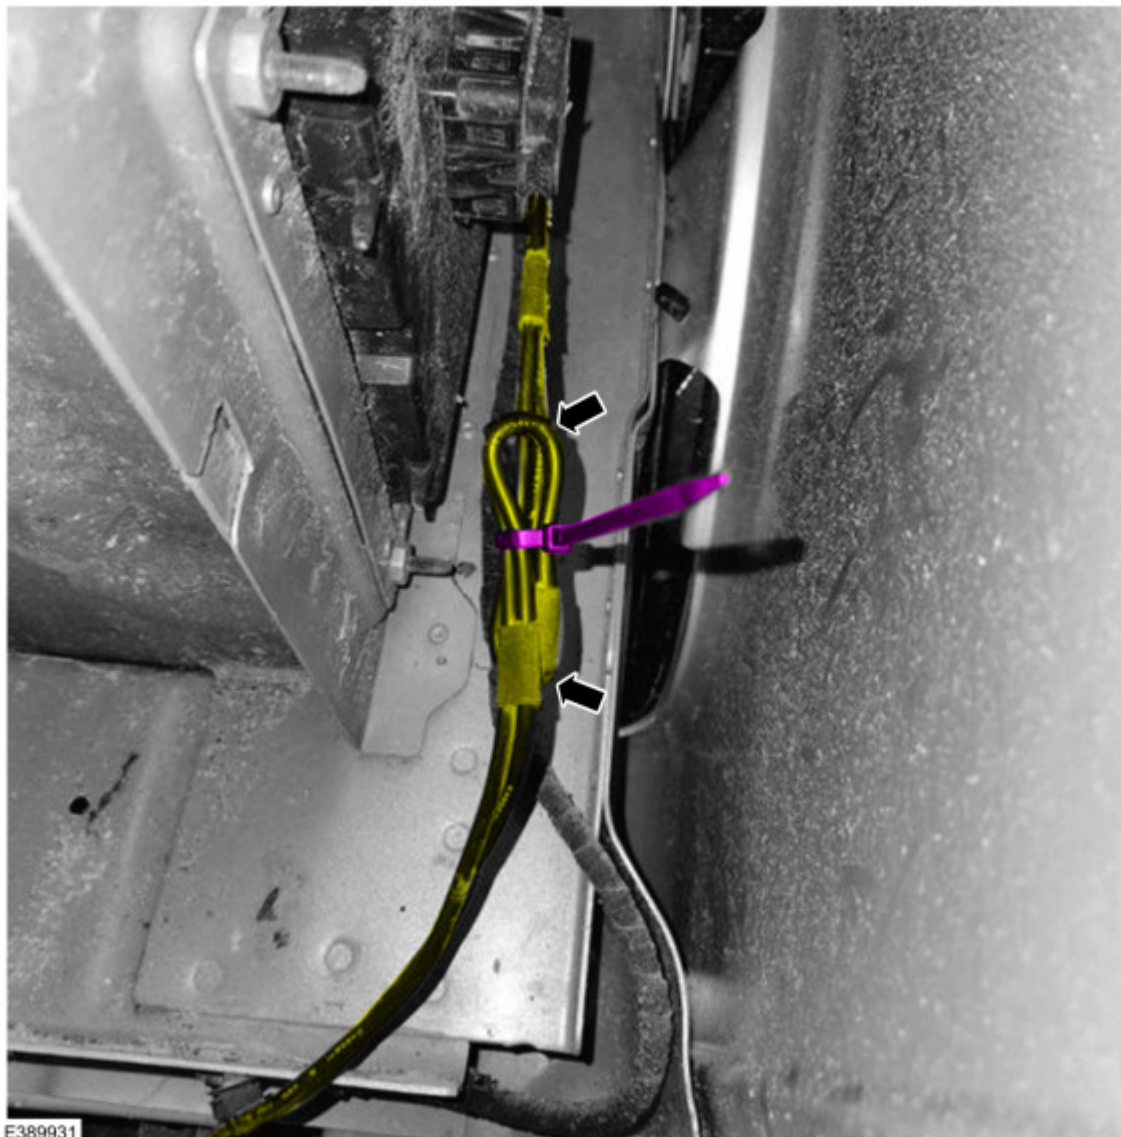
Figure 5

**⚠ CAUTION:** The bend radius of the pickup bed AC power outlet socket harness should be no less than 4 mm. Hard kinks and tight bends of the pickup bed AC power outlet socket harness can lead to wire damage.

6. Fold approximately 7 in. (185 mm) of the remaining/loose pickup bed AC power outlet socket harness in 2 bends just behind the pickup bed AC power outlet socket panel. Secure the folded wire with a wire tie. Inspect the routing of the harness to make sure it is not pulled too tight against the body sheet metal near the harness retainer and provides just enough length. (Figure 5)
