# Technical Service Bulletin

## 91 No diagnostics communication to the telematics control module; DTC U142100

91 23 49 2056076/20 November 17, 2023. Supersedes Technical Service Bulletin Group 91 number 23-19 dated August 8, 2023 for reasons listed below.

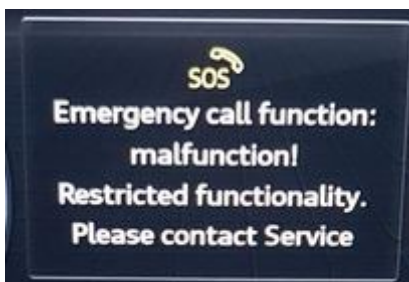
- An SOS Warning might be displayed in the instrument cluster (Figure 1).

Figure 1. Emergency call malfunction warning.
