# Service Alert

**TELEMATICS MALFUNCTION MESSAGE AND MASTER WARNING  
LIGHT ON. DTC U3000:04 STORED**

**Service Alert No.: SA-034/23**

2024 CX-90

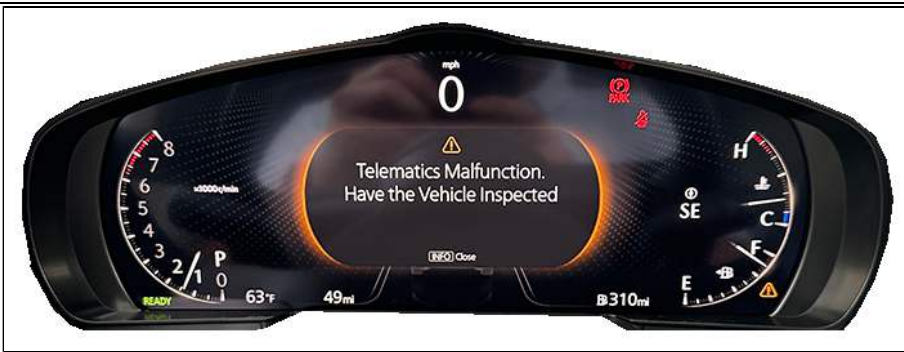
| Telematics Malfunction.<br>Have the Vehicle Inspected<br>error message | |
| Master Warning light ON | |

DTC U3000:04 (Telematics communication unit internal malfunction) is stored.

3. Disconnect the battery for 1 hour, then reconnect the battery.

4. Check status of DTC U3000:04 and verify status is "Past".

5. Clear DTC.

6. Verify the repair.
