# Service Bulletin

Bulletin No.: 23-NA-165

**Subject:** Vehicle Will Not Lock and Unlock (Loss of Active Functions) Crank or Start (Loss of Passive Functions) with DTC P0513 Set

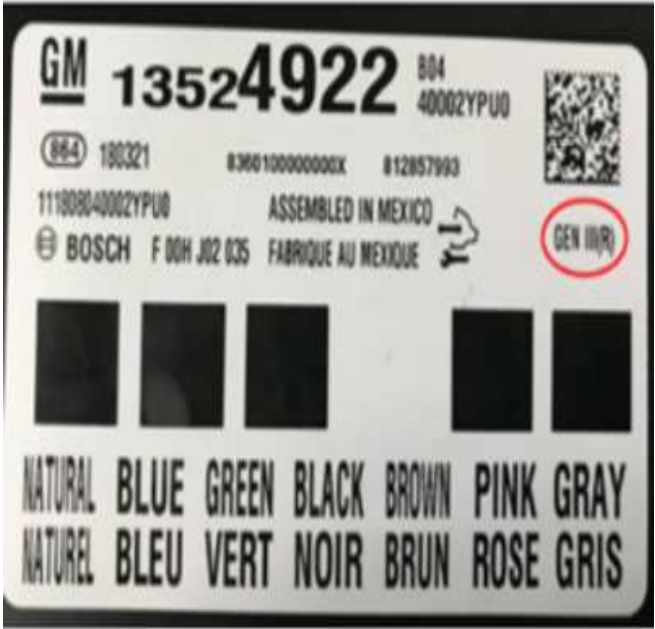
| <p>Correction</p> | <p>Important: Do not attempt the immobilizer procedure or module replacements before following this bulletin.</p> <p>This procedure ONLY applies to the GEN3R BCM</p> <p>GEN3R BCMs can be identified by either the label on the module or looking up the BMPN part number information in GDS2.</p> <div data-bbox="683 304 1333 336"></div> <div data-bbox="683 438 1333 1062"></div> <div data-bbox="683 1163 1333 1194"></div> |

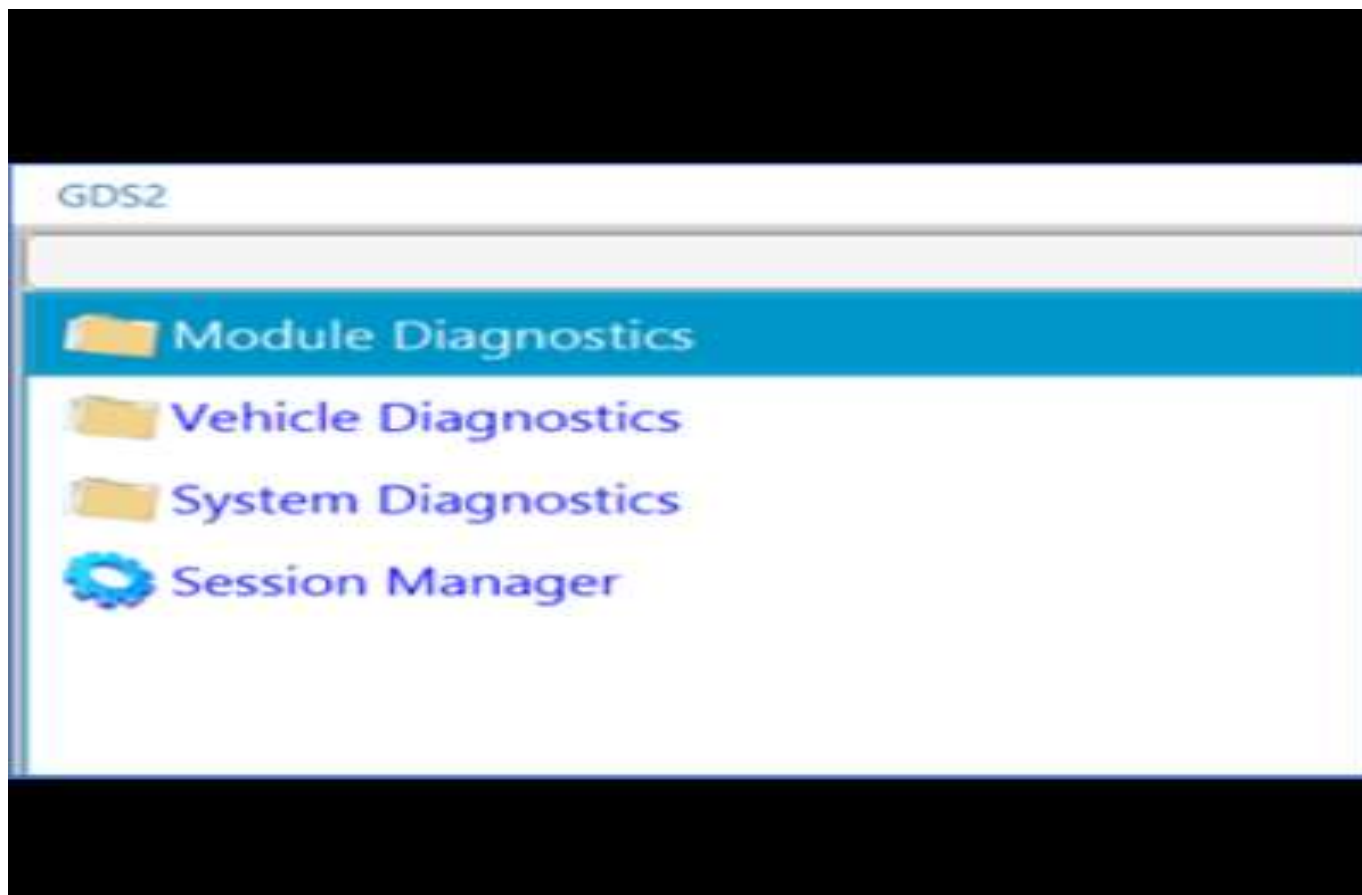
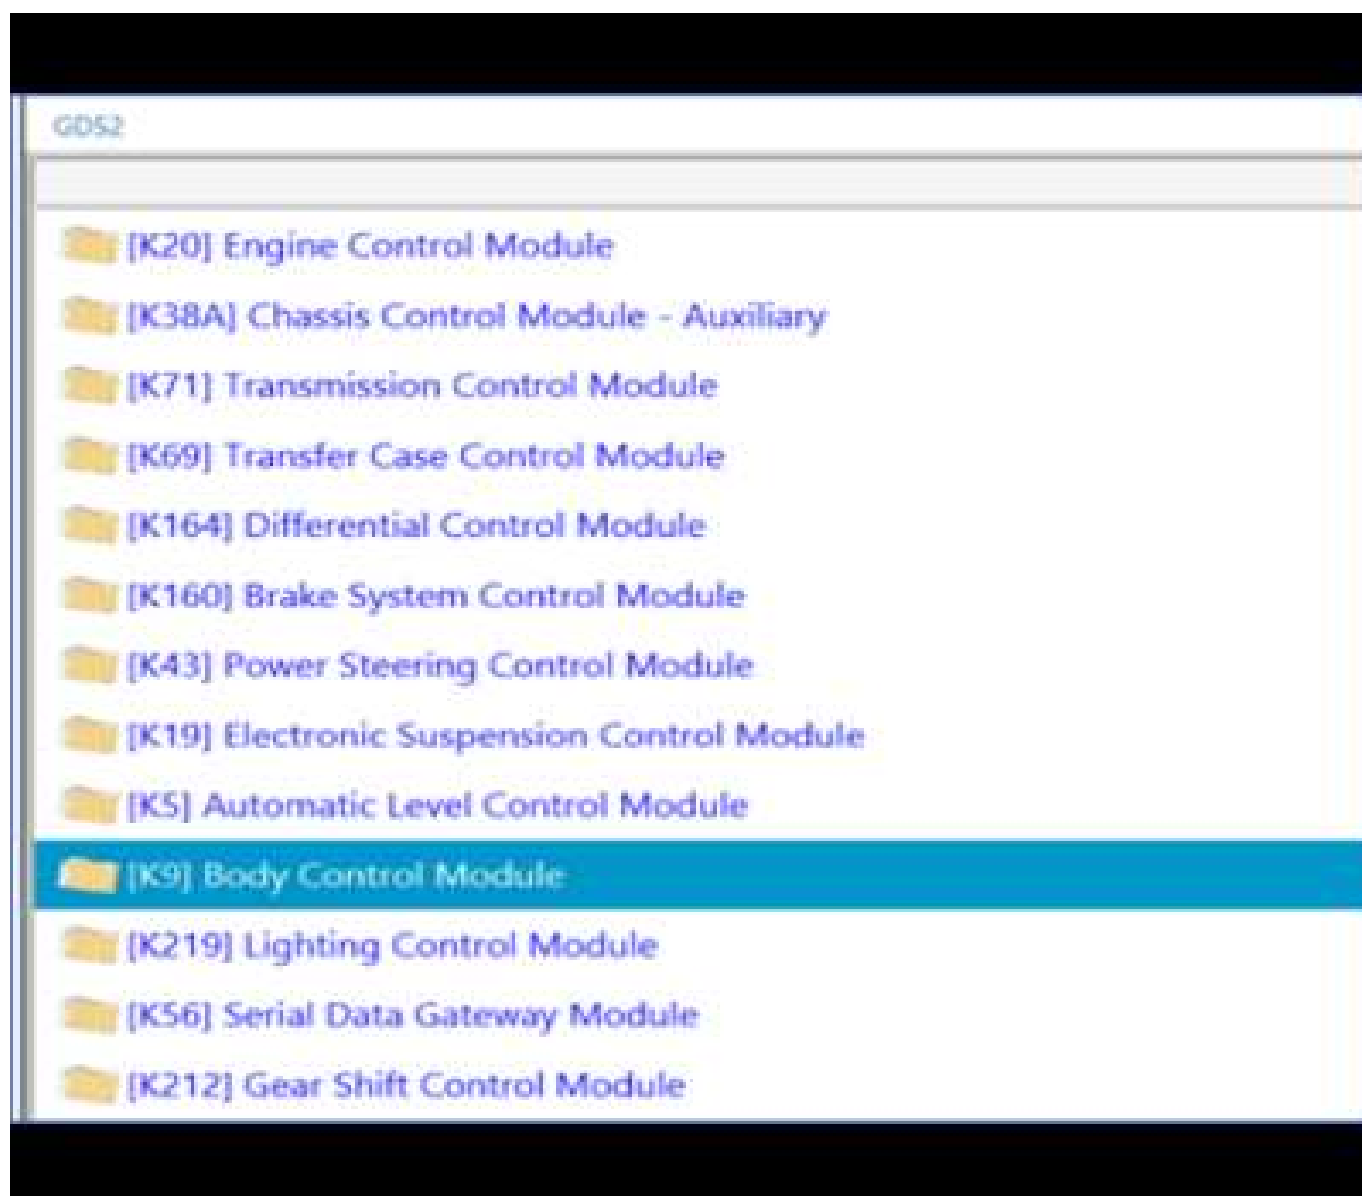
Verify you have a GEN3R BCM Base Model Part Number. Only GEN3R BCMS are eligible for this bulletin. Navigate to GDS2 > Module Diagnostics > [K9] Body Control Module > Identification Information > Identification Information.

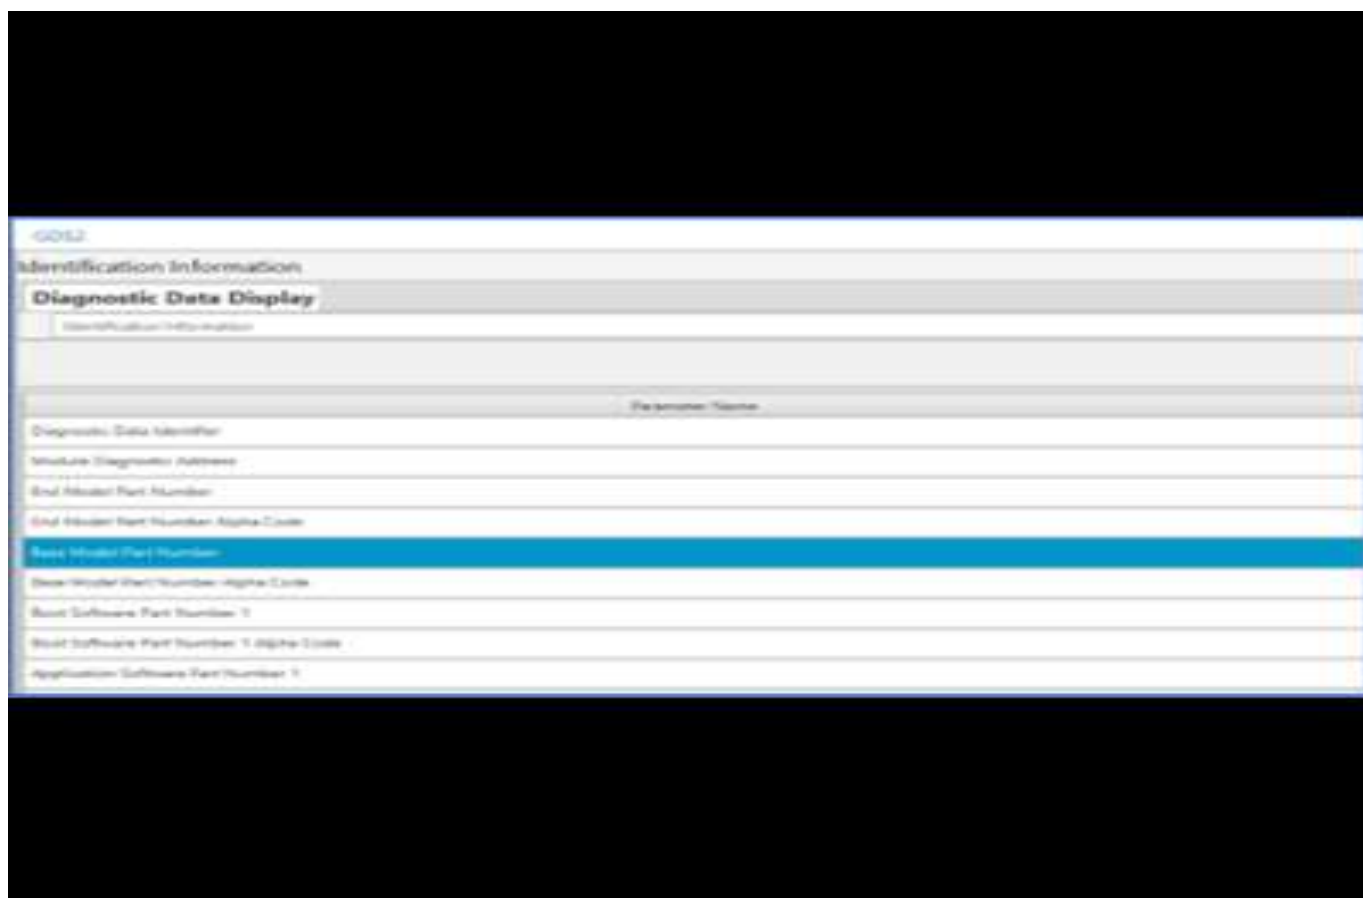
6430394

BMPNs eligible for this bulletin: 13518569, 13518570, 13518602, 13518603, 13519619, 13519620, 13519648, 13527252, 13527260, 13527261, 13527297, 13527298, 13527827, 13529492, 13529493, 13533809, 13533813, 13533814, 13533817, 13533821.
