# Technical product information

| Topic | DTC B101C29 and/or DTC B101D29 evident within the airbag control unit (J234) |
| Brand | Bentley |
| Transaction No. | 2071047/3 |

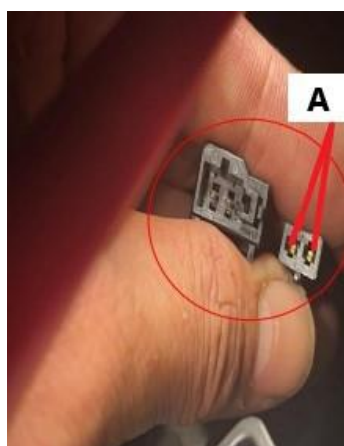
Hint: The next part of the procedure requires the resistance of the seat belt buckle harness to be measured. The resistance measurement must be taken at the location shown in Figure 3 (Point A) The operative must take care not to damage the terminals shown at point A when taking the resistance measurements

5) Referring to Figure 3 - Disconnect the E24 connection (circle)
