## Technical product information

| <b>Topic</b> | DTC B17B801 and/or B17B804 - evident within address 0019 and/or DTC U112300 evident in 00A5 |
| <b>Brand</b> | Bentley |
| <b>Transaction No.</b> | 2063855/9 |

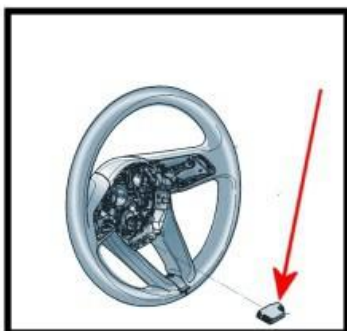
Lane Assist and/or Traffic Assist are not functional

- DTC - B17B801 - Steering Wheel Touch Recognition Control Module evident within **address 0019**

- DTC B17B804 - Steering Wheel Touch Recognition Control Module electrical error - evident within **address 0019**

- DTC U112300 with symptom Code 1123220 within **address 00A5**

- 1) Referring to Rep.Gr 69 - Remove the driver's air bag
- 2) Referring to Figure 1 - Replace the Steering Wheel Contact Detection control unit (J1158)
