## Cayenne E-Hybrid – Thermal Management Fault P26B100 Causes Check Engine Light

**Bulletin #: 2221.3**

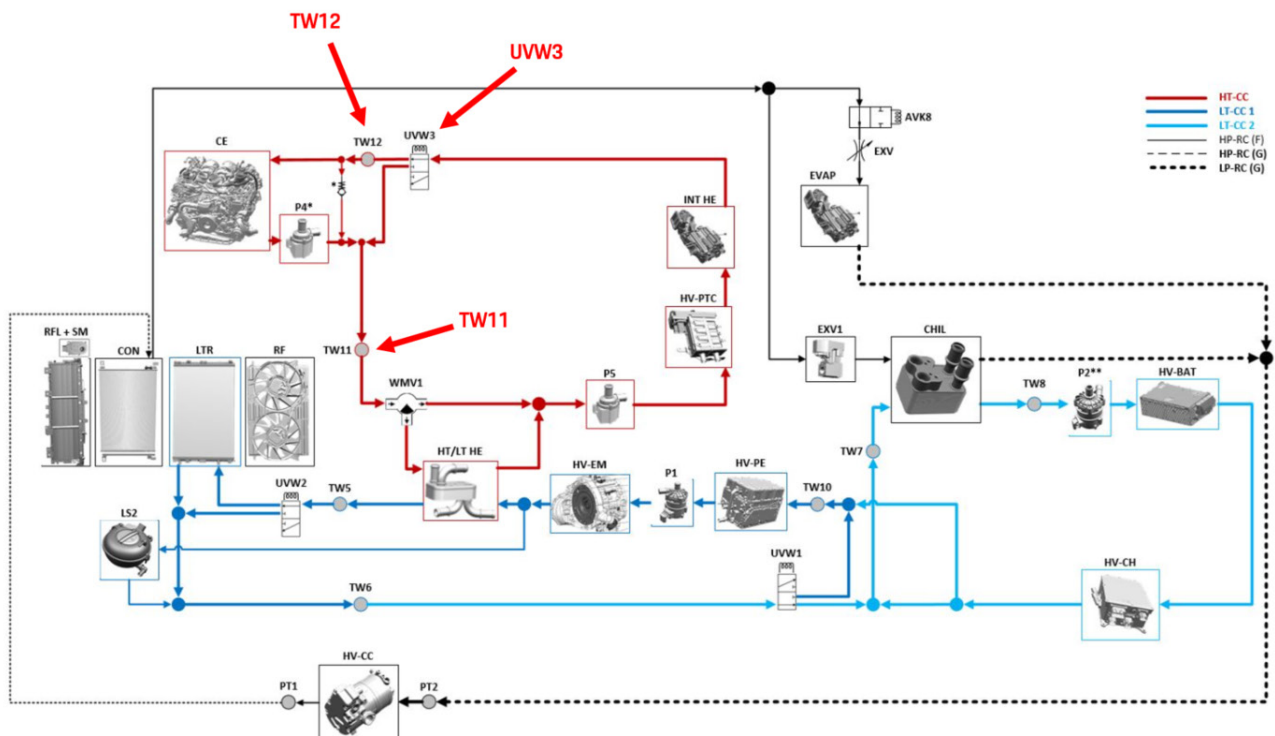
Figure 1 - Cayenne E-Hybrid Cooling Circuits

Valve UVW3 controls the direction of coolant flow based on engine temperature. The valve defaults to closed, such that the high-temp circuit excludes the engine coolant circuit. During this "small-circuit" operation, the HV PTC controls the temperature of the high-temp circuit to meet the heating and air conditioning demands of the customer. Once the engine reaches 40° C, the valve opens ("large-circuit" operation) and the high-temp circuit uses the engine heat instead of the HV PTC.

The status of UVW3 is diagnosed by the absolute value of the temperature difference between TW11 and TW12. The TME expects this difference to be **larger than 7° C while the valve is closed, but smaller than 7° C while the valve is open**. Certain operating conditions may cause the temperature difference to fall below 7° C while the valve is closed. If this condition exists while the TME is performing diagnostics, the valve will be diagnosed as open, although it is closed due to the engine temperature being less than 40° C.

1. Please create a VAL to document the occurrence of the fault.
2. Workshop Campaign WPRO has been launched for MY20-23 as of November 15, 2023. Please complete this Campaign per the instructions in TI 177/23, if applicable, before performing any other diagnosis work for the subject fault code.
3. If the fault persists after performing WPRO, please continue with other means of diagnosis.
