**Bulletin #: 2104.6**

### Y1A Taycan

### On Board Charger (OBC) Fault P31D200 "Charging Socket – Overtemperature"

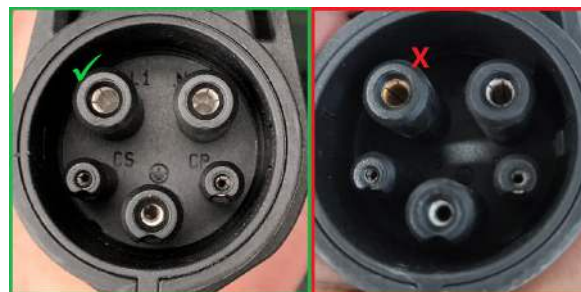
Figure 3

Visually inspect the pins in the vehicle cable connector for signs of overheating, paying particular attention to the L1 Pin. A vehicle cable and L1 Pin which was significantly or repeatedly overheated will show signs of discoloration (refer to Figure 3).

New vehicle cables are available with thicker wiring to prevent repeat occurrence of this condition.

Customers with a Mobile Charger Connect (PMCC) who experience the condition described above shall receive a new, thicker vehicle cable in exchange for the failed vehicle cable.
