| <b>Topic</b> | New Continental GT and GTC - Window drop glass operation |
| <b>Transaction No.</b> | 2070497/6 |

- Incorrect operation/function of the front and/or rear window drop glass
- Front and/or rear drop glass fails to open/close or attempts to close and re-opens once contact has been made between the glass and applicable seal
- DTC for window regulator motor no basic setting B148754 evident within any of the 4 window control modules (diagnostic address 42, 52, BB and BC) for loss of basic settings

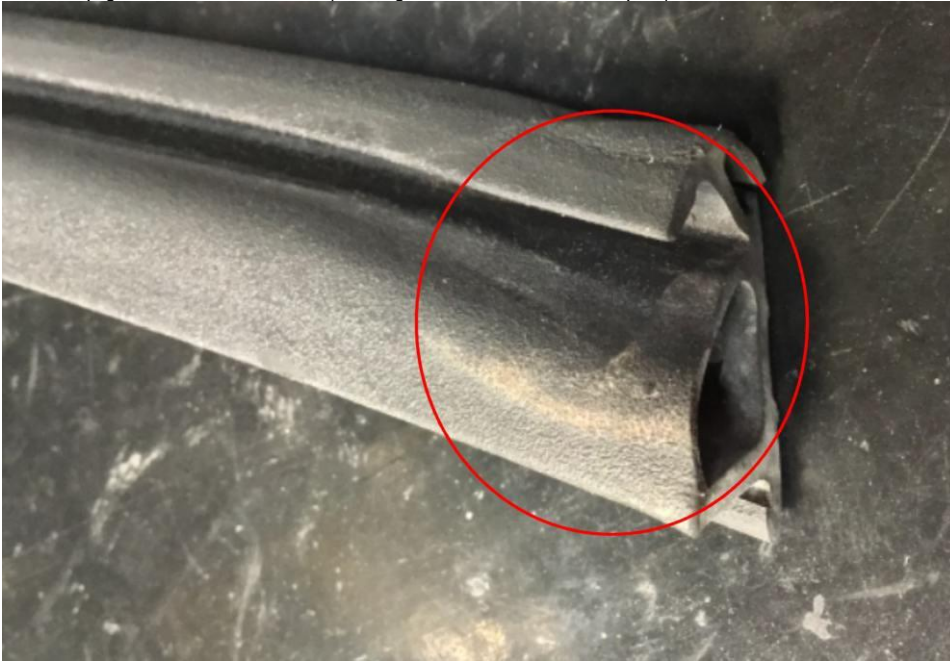
Figure 9

- Damage
- Splits
- Tears
- Misalignment
- Incorrectly fitted/located
- Drop glass seal deformation (see Figures 9 and 10 as examples)

NOTE: Any issues found with the window seals must be rectified before conducting the remaining steps

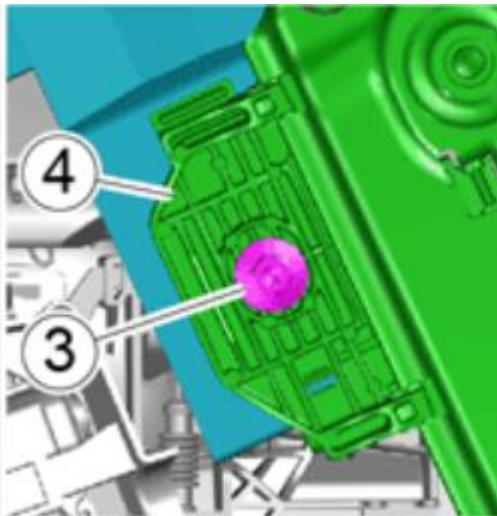
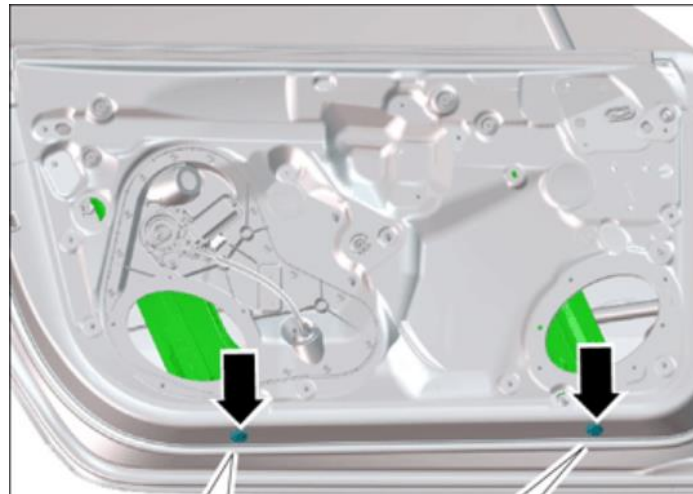
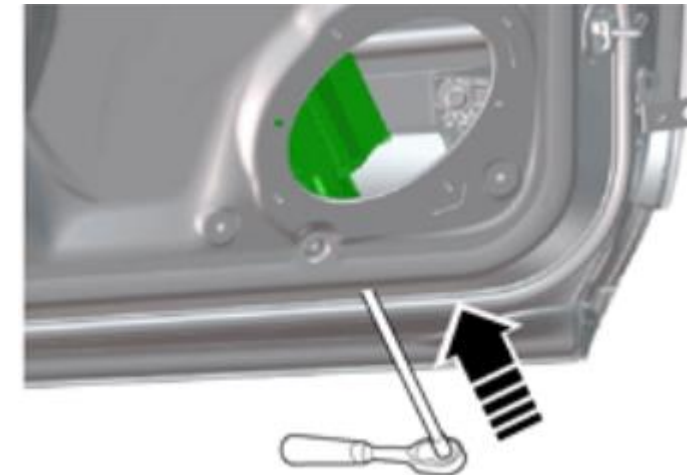
Example: Front drop glass Z axis not adjusted correctly. Bottom of tape was level with waist rail seal, after slackening pinch bolt (3 in bottom left image) front drop glass lowered 14mm to where pen marked line is.

Z-axis adjusters (bottom middle and right images) had not been used, pinch bolt had been slacked and glass lifted out of the regulator to achieve specification. This has a knock on effect of altering the 10mm division bar intrusion seen in previous slide as glass is loose and can be accidentally moved in X-axis.

This also creates a risk that the window will bottom out on the cant rail seals rather than the regulator bump stops meaning that the glass can raise further as the seals soften over time and affect end stop learning.

## Z-Axis height should only be adjusted by the 4mm Allen key adjusters as per ELSAPRO

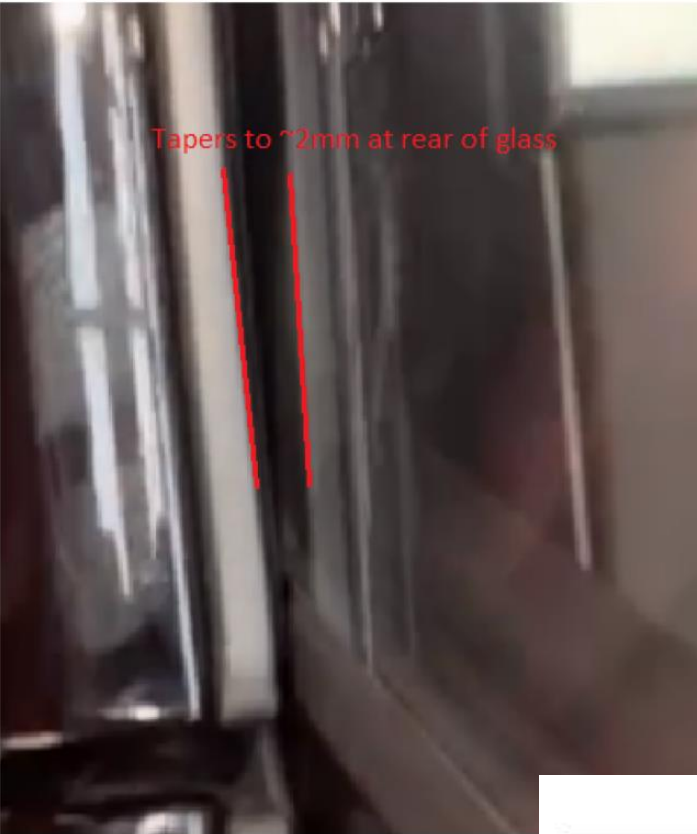
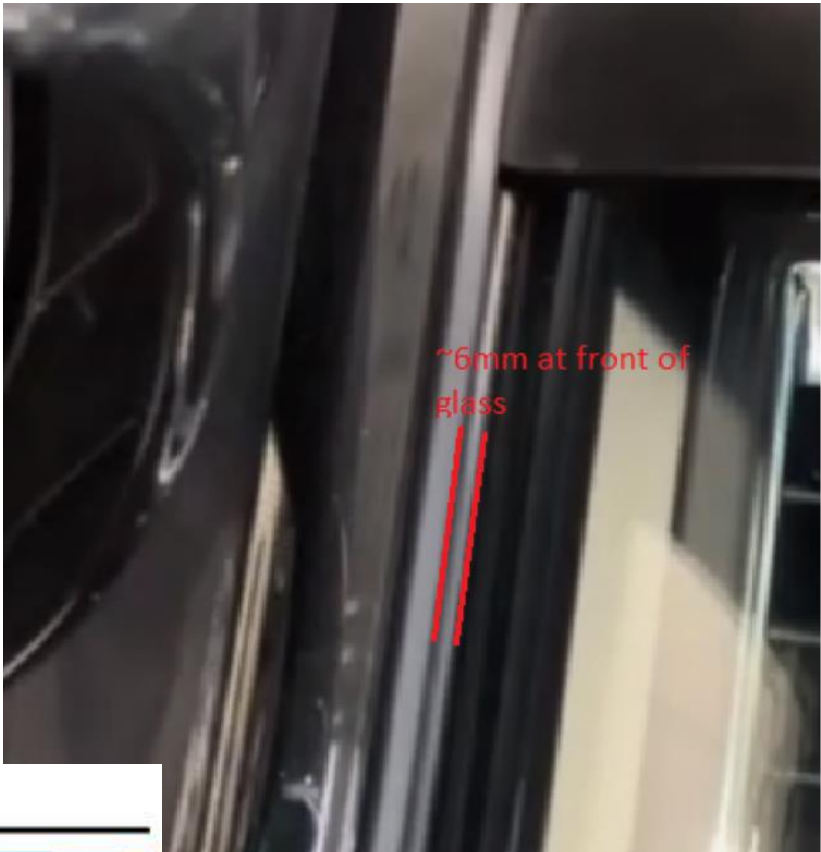
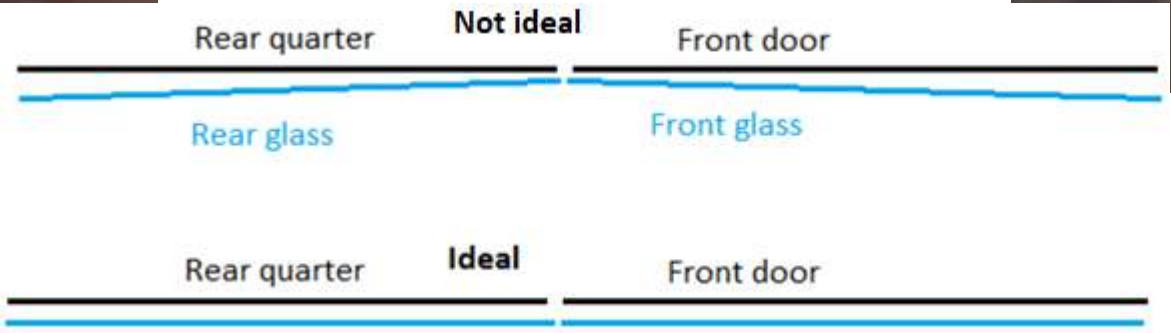
Images show a poor setting.  
Circa 6mm at front edge (near wing mirror)  
closing up to 2mm at the rear edge.

2mm at rear edge would have been set to achieve specified flush/2mm underflush profile condition between front and rear glasses, the rear quarter glass mirrors this taper condition. This potentially increases the risk of false anti trap as rear window/seal does not engage with front window at the correct angle. Suggested to set to specification on problem vehicles as per next slide. If both windows are set between 4-6mm then the flush/2mm underflush profile can be easily achieved.

Set waist rail gapping to between 4-6mm as mentioned in Glass setting guide videos on E-Academy and also check for parallelism along front and rear windows to door/quarter. 50mm from edge of Waistrail seal, roughly underneath the Bentley wings.
