# Technical Service Bulletin

## 69 Airbag warning light on, DTC: B10041B stored in the airbag module

69 23 04 2072122/1 December 1, 2023.

| Model(s) | Year | VIN Range | Vehicle-Specific Equipment |
|---|---|---|---|
| Q4 e-tron, and<br>Q4 Sportback e-tron | 2022 – 2024 | All | Not Applicable |

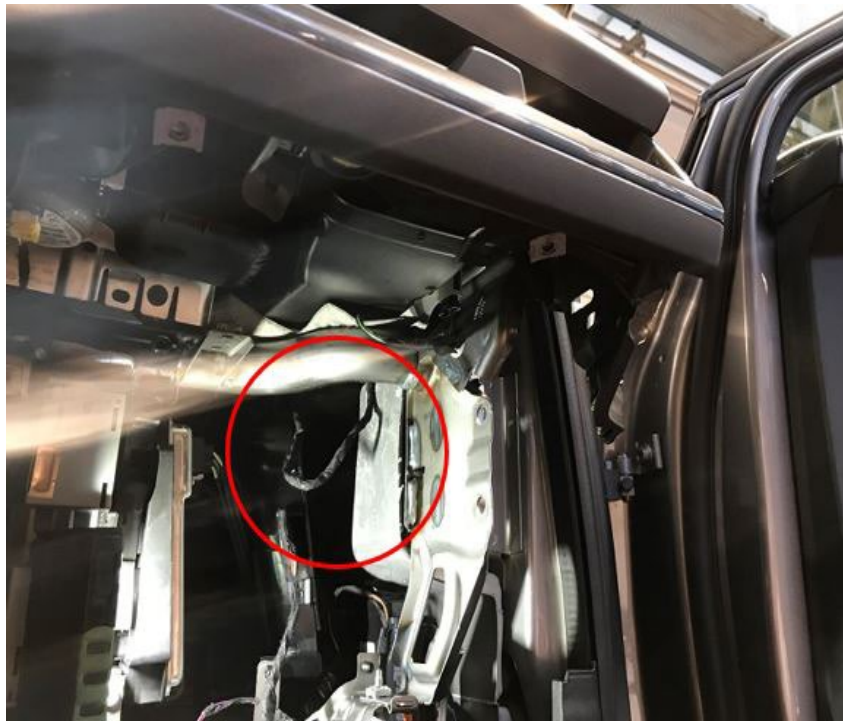
During production the wire harness may have been pinched during assembly.

**Figure 1:** Location of harness inspection.

1. Remove the glovebox and inspect the harness routing in the area of the red circle shown in Figure 1.

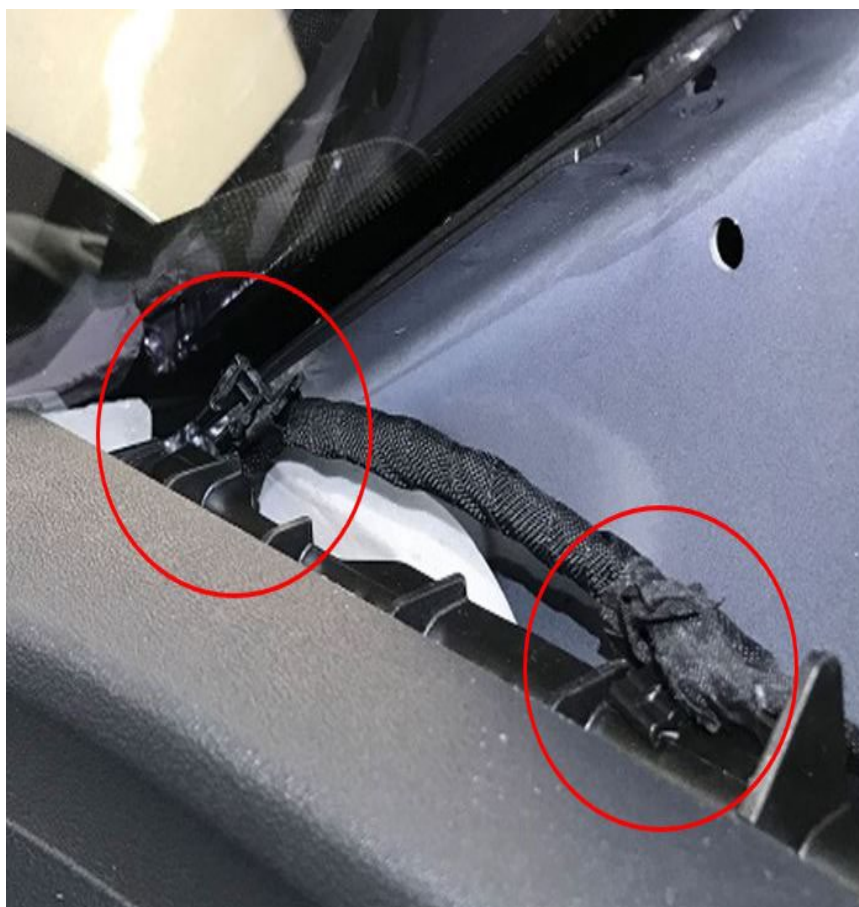
**Figure 2:** Unclip the harness.

2. It may be necessary to loosen the harness in order to inspect/repair.

- Remove the passenger A-pillar trim.
- Unclip the harness from the securing tabs indicated by the red circles in Figure 2.

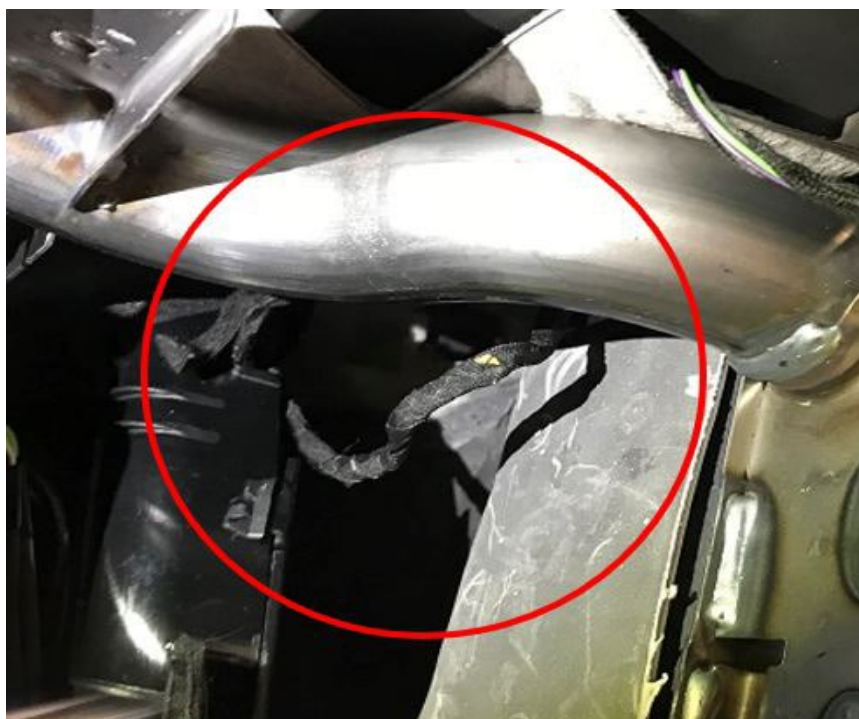
3. Inspect the harness closely as the damage may only be visible after removing the harness tape.

**Figure 3:** Secure the wires.

Repair the affected wires using wiring harness repair set **VAS 1978 B/C**

Secure the wires as needed to ensure they no longer contact other components (Figure 3).
