PIT6088 Diagnostic Tip - Lack Of Power Steering Assist With DTC P25A2 C1597 and/or C1599

Product Investigation Review Required

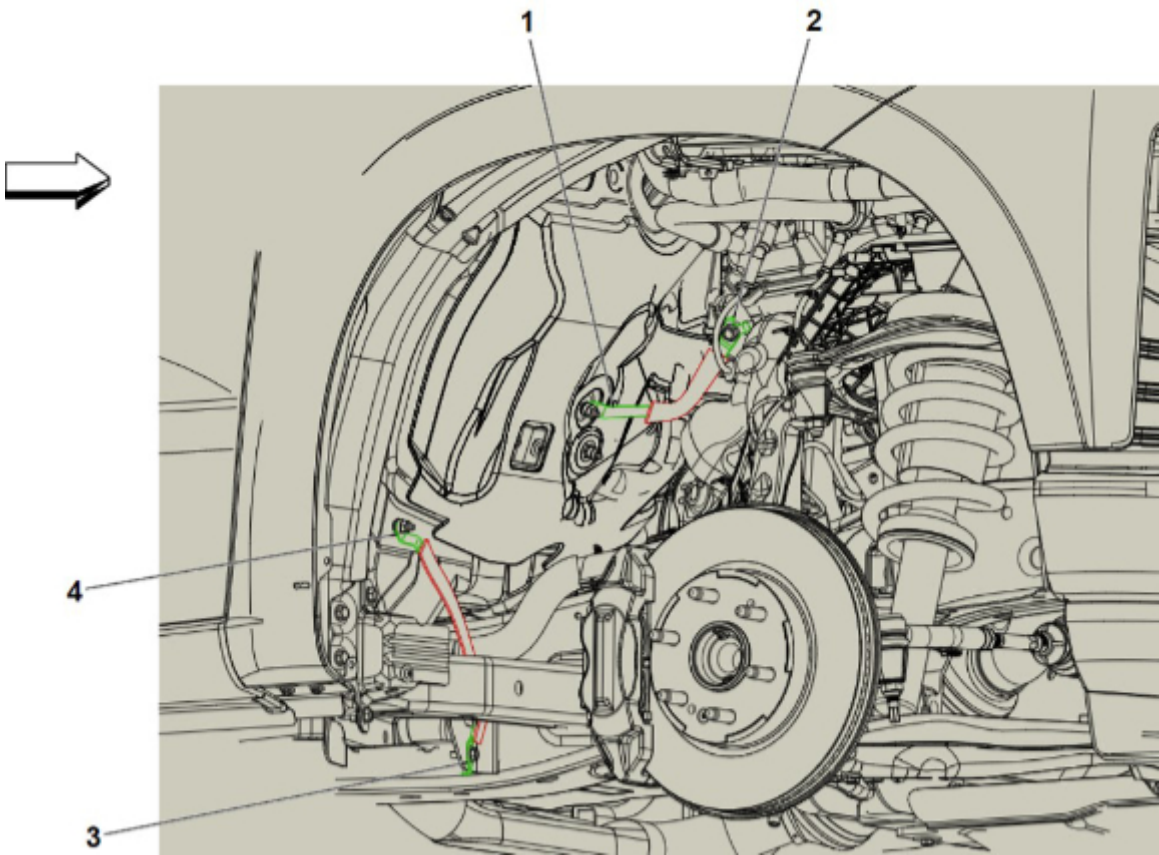
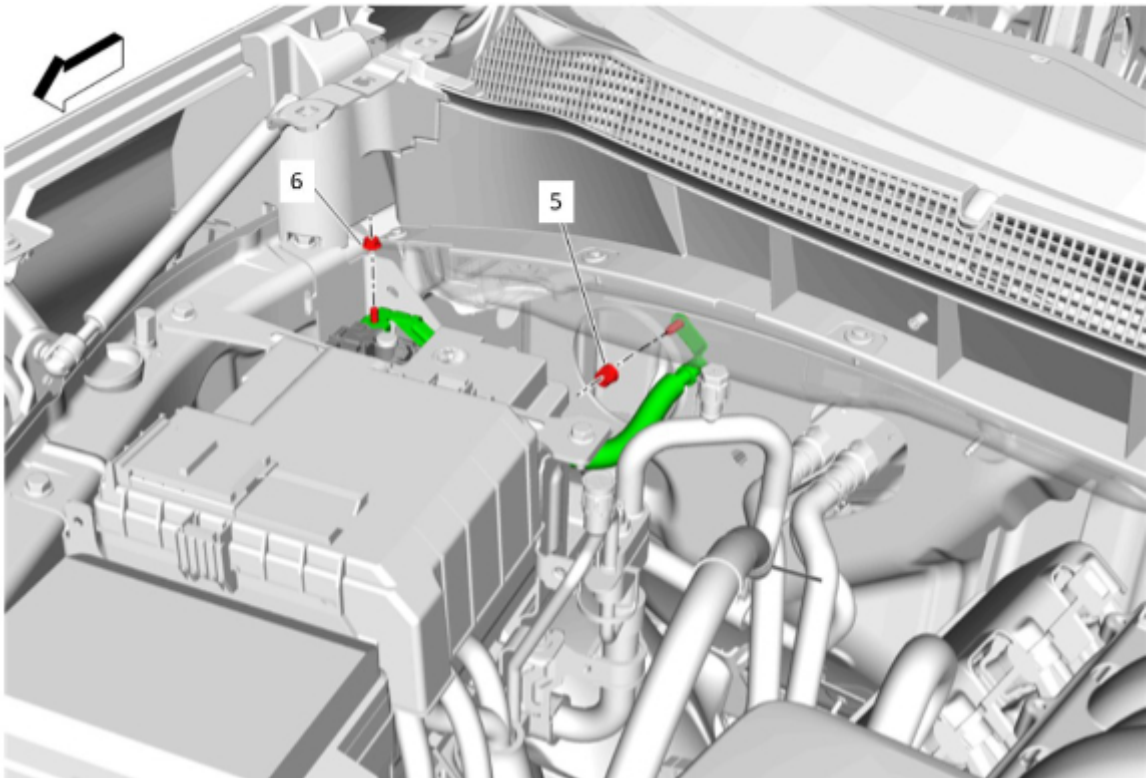
| Condition | Some customers may comment on a lack of power steering assist. When checking for DTC's a C1597 and/or C1599 may be set in the power steering control module. |
| Cause | The cause of this concern could be a poor ground at one of the main ground cable/strap connections. |

- (1) G132 Engine Ground Strap
- (2) G134 Engine Ground Strap
- (3) G131 Frame Ground Strap
- (4) G133 Frame Ground Strap
- (5) G130 Battery Negative Cable at Body Ground
- (6) Battery Negative Cable

Inspect the following main ground strap/cable connections, shown below, to make sure they are clean and tight. Also, inspect for any corrosion at the connection or a corroded braided strap/cable. Lightly pull on the ground straps to make sure they do not break in two and the eyelet connections do not move or break. Replace and/or repair any issues found.
