# Technical Service Bulletin

## 69 Airbag warning light on, DTCs B100A1B, B100B1B

69 23 05 2072349/1 December 13, 2023.

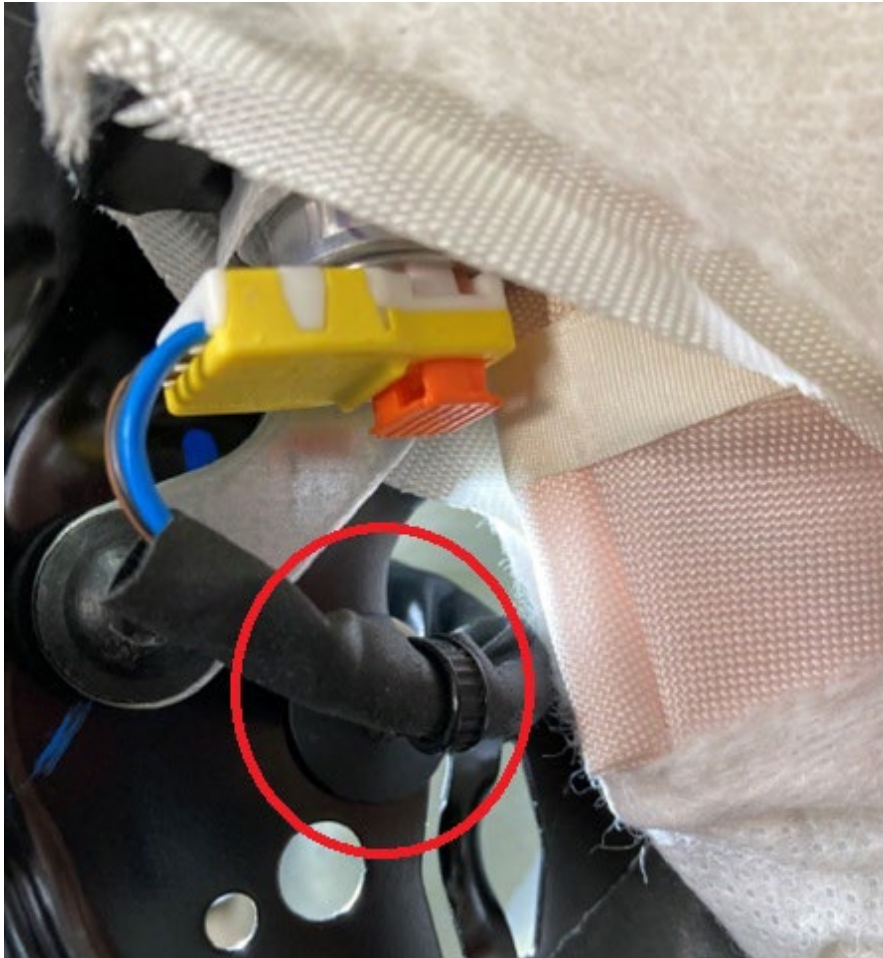
The wire harness of the side/thorax airbag is too close to the seat foam. The seat foam presses on the wire harness causing movement of the airbag connector, resulting in an increase in electrical resistance.

**Figure 1.** Install additional zip tie/clip when installing new thorax airbag wire harness.

- Replace the affected side/thorax airbag wire harness(es) according to: *Elsa>>Repair manual>>Body>>Body Interior>>Passenger Protection, Airbags, Seat Belts>>Thorax Airbags>>Thorax Airbag Wire, Removing and Installing.*
- Route the new thorax airbag wire harness(es) as close to the seat frame as possible. To do so, use zip tie/clip **N10546701** (Figures 1, 2).

**Tip: The clip in the photo is not identical with the clip to be used.**

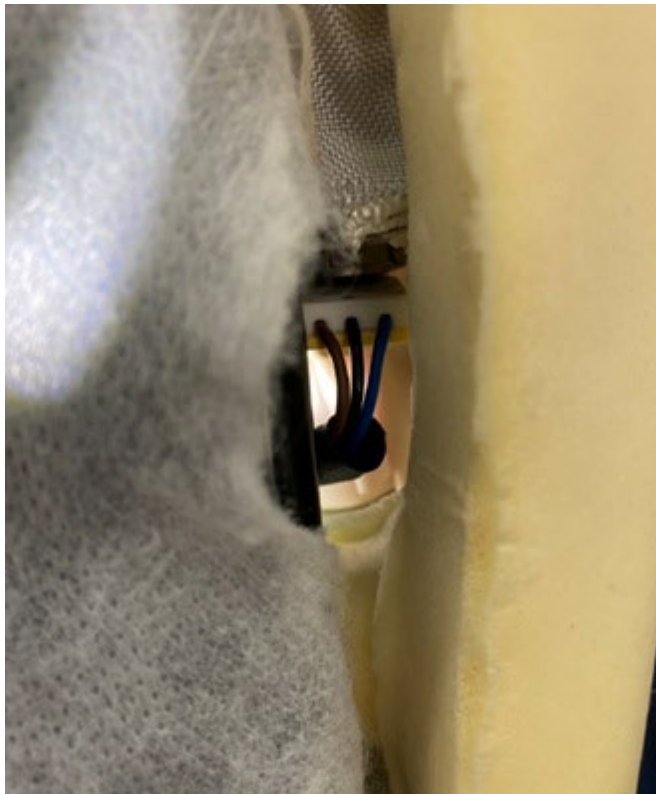
**Figure 2.** Route new thorax airbag wire harness as close to seat frame as possible.
