# Technical Service Bulletin

## 87 Air distribution or heating/cooling adjustments inoperative - B109209, B174F09, B109009, B116909, B108C09, B10B709

87 23 66 2070449/2 December 18, 2023. Supersedes Technical Service Bulletin Group 87 number 23-42 dated May 30, 2023 for reasons listed below.

| Model(s) | Year | VIN Range | Vehicle-Specific Equipment |
|---|---|---|---|
| e-tron GT, and RS e-tron GT | 2022 – 2024 | All | Not Applicable |

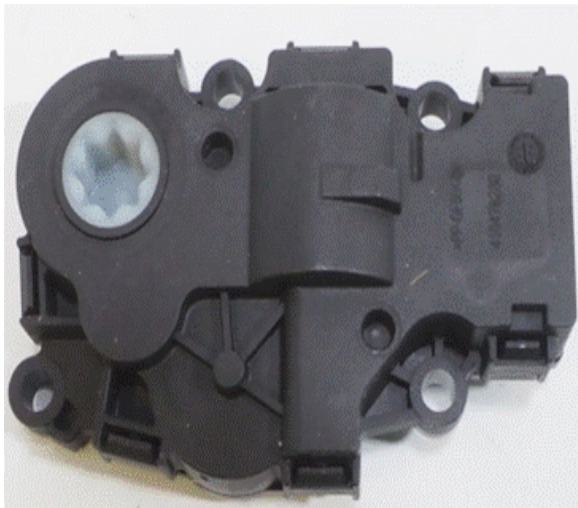
| 8W0820511F | | Quantity necessary |

| | Motor for adjustment | |
