### 992 2WD – DME Fault P310B00 – ‘Fuel Low Pressure – Implausible’

#### Vehicles Affected

#### Condition

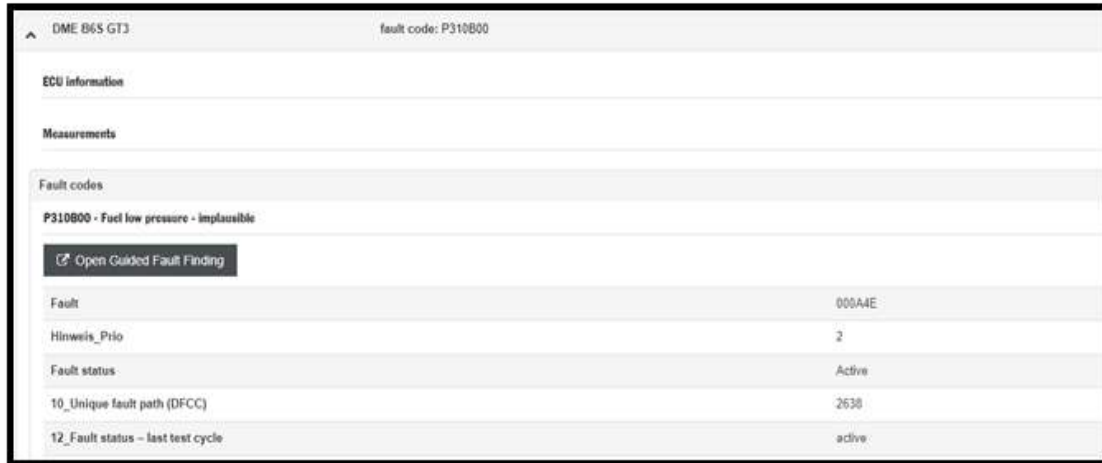
**Figure 1**

The diagnostic responsible for this fault monitors supply deviation within a finite time between the demanded or target low-pressure requested of the low-pressure fuel pump and that of the actual supplied quantity to meet the request, as correlated to pressure. In some instances, manufacturing tolerances for the low-pressure pump result in the actual supplied fuel quantity exceeding the DME's requested quantity, in other words, the pump's operation is 'too effective.' By consulting the Vehicle Analysis Log (VAL) containing the fault it is possible to see if the supplied fuel quantity exceeded the requested quantity in the low-pressure system to cause the fault.

If the fault data is consistent with the condition exemplified in Figure 1, please replace the fuel pump, **NOT** the fuel pressure sensor.

A software update to correct the diagnostic boundary parameters is available for GT3.

1. Follow the instructions from Guided Fault Finding to rule out any other possible fault causes.
2. Referring to Figure 2. Identify measurement values for **XX\_Adaption value for low fuel pressure and A260\_Fuel pump control unit activation**.
3. Follow **WM 206619 – Removing and installing fuel pump** to *replace the fuel pump*.
4. Verify the repair by monitoring the low-pressure fuel delivery under the engine operating parameters of the fault's environmental data.

1. Perform DME programming with PIWIS Tester version 42.400.020 or newer Target DME Porsche Part numbers from table below:
