# Technical Service Bulletin

## 27 48V vehicle electrical system warning, DTC U046900 stored in the ECM

27 23 64 2058831/11 December 22, 2023. Supersedes Technical Service Bulletin Group 27 number 23-63 dated December 13, 2023 for reasons listed below.

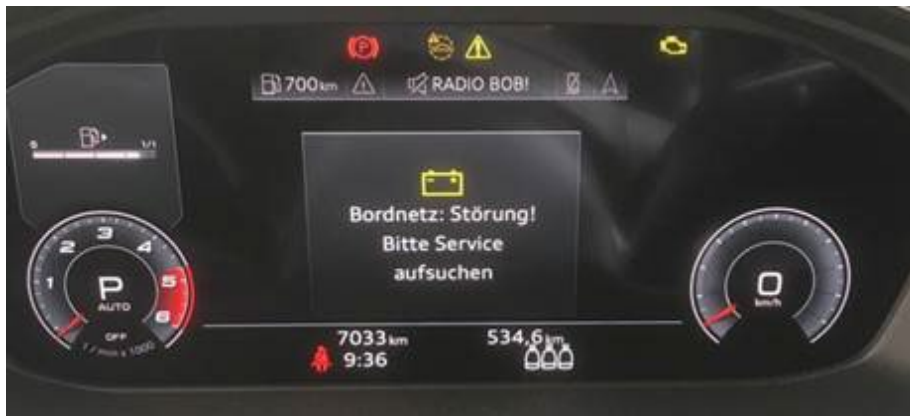
**Figure 1.** Cluster Warning Message.

- The message “Electrical system: Malfunction. See owner’s manual” is displayed on the instrument cluster (Figure 1).
- A yellow or red battery warning symbol is displayed on the instrument cluster.
