**WARNING LIGHT WITH P0531 AND/OR A/C DOES NOT WORK**

**Service Alert No.: SA-084/23**

2023 CX-90 PHEV

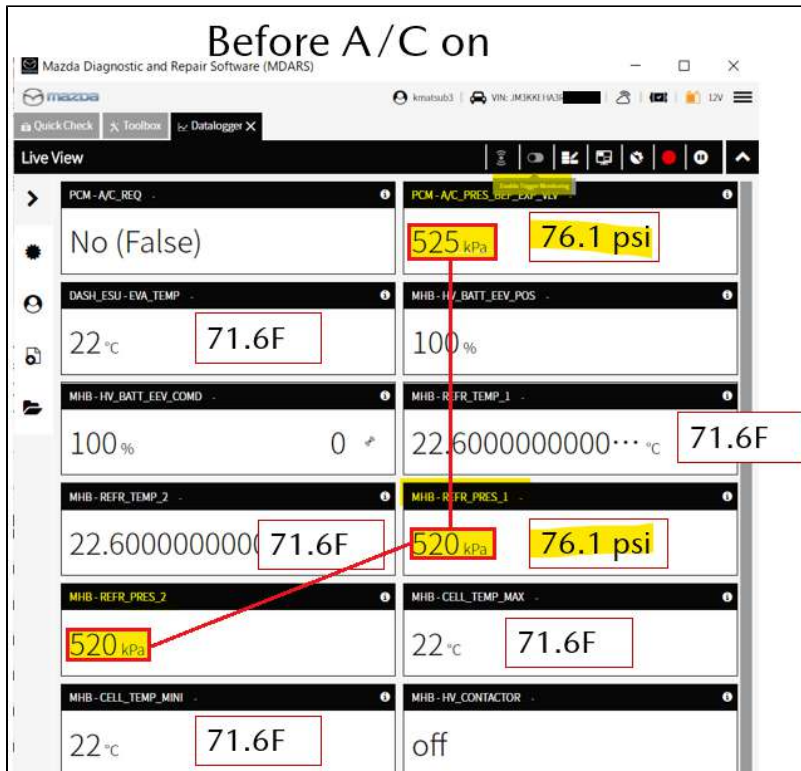
- **P0531:00 [PCM (e-SKYACTIV PHEV)]**

**NOTE:** After a few hours without using the A/C, the readings from the three A/C pressure sensors should nearly align if the sensors and wiring are OK.
