# Technical Service Bulletin

CHECK ENGINE LIGHT ON WITH DTC P0126:00

Bulletin No.: 01-005/23

Last Issued : 12/20/2023

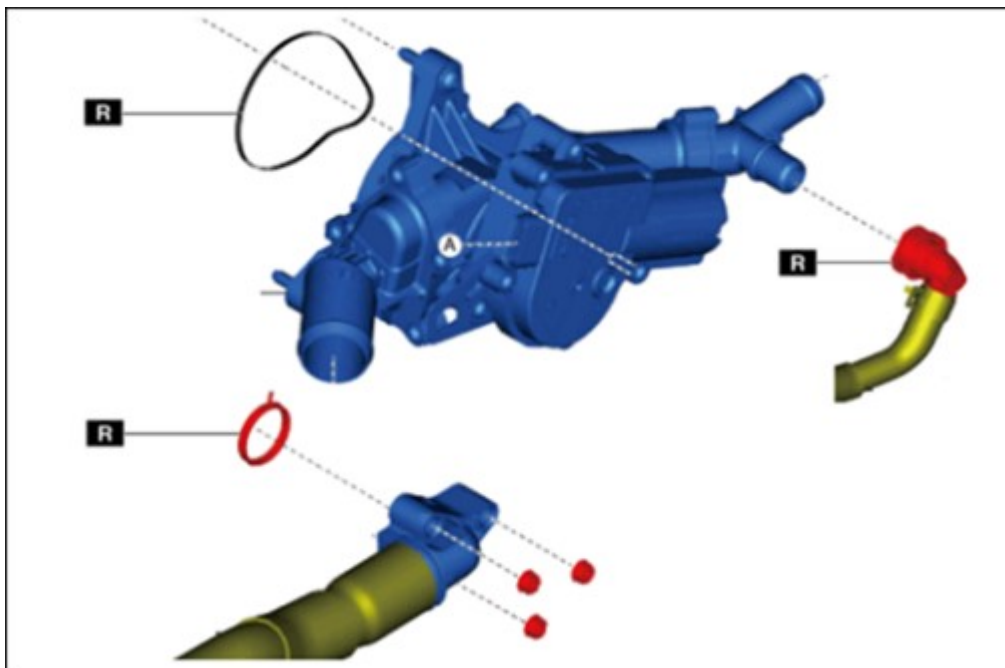
**Replacement Part Locations**

- O-ring
- Gasket
- Connector

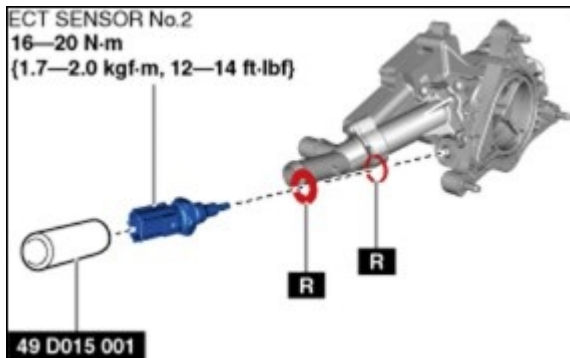
- O-ring and washer for ECT sensor No.2
