## Technical product information

| <b>Topic</b> | Rotating display/screen - Fault diagnosis - Mechanical malfunction DTC B140107 is evident within 005F |
| <b>Brand</b> | Bentley |
| <b>Transaction No.</b> | 2067955/4 |

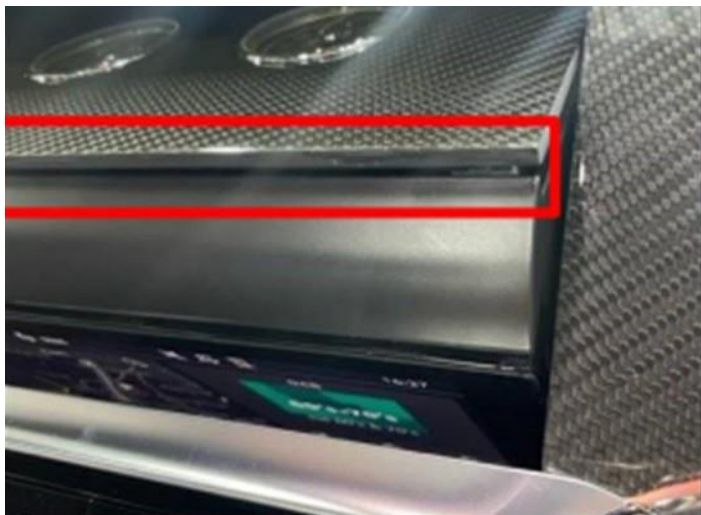
Figure 1

4) Figures 1 and 2 show an example of the display clocks and/or dials fascia unclipped)

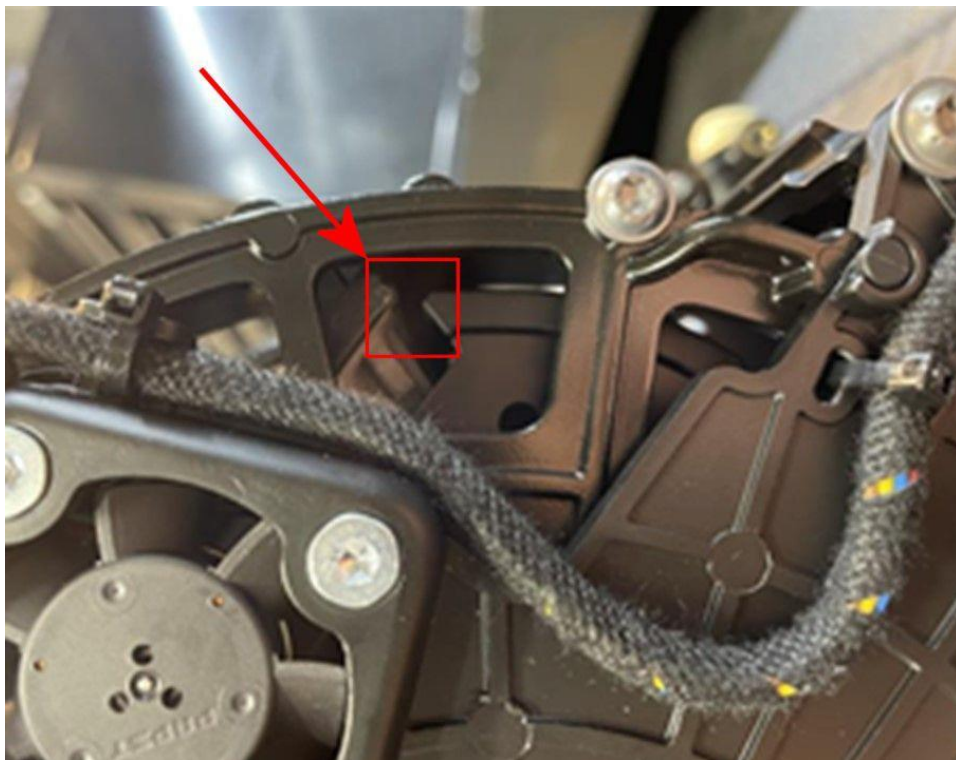
Figure 2

**Please note: The BRD must be removed (Rep.Gr 91) to allow visual inspection of the panel at the back of the BRD for signs of unclipping (Figure 2)**

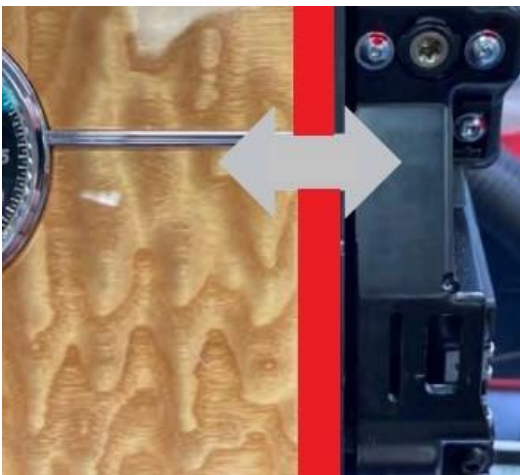
Figure 4

- **HINT: Referring to Figures 4 and 5, if there is a large gap on one side of the fascia panel and a small gap on the opposing side or a report of clashing with driver fascia or clunking the operative should check to confirm the bearings of the unit have not displaced as shown in Figure 6**

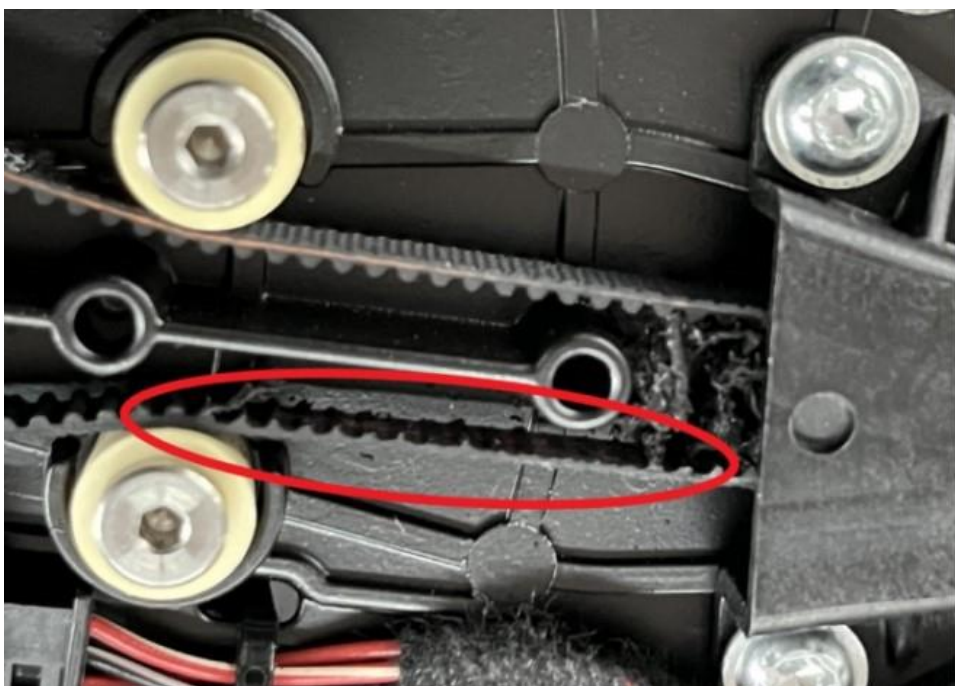
Figure 7

8) Belt drive check (Figure 7)
