**Technical Service Bulletin (TSB)**  
**Transfer Case Shift Motor Wire Harness Connector Not Secured**

| REFERENCE: | TSB: 08-239-23<br>GROUP: 08 - Electrical | Date: | November 7, 2023 | REVISION: | – |
| VEHICLES AFFECTED: | 2023 (WS) Grand Wagoneer/Wagoneer<br>This bulletin applies to vehicles built on or after June 16, 2023 (MDH 0616XX) and on or before June 24, 2023 (MDH 0624XX). | | | MARKET APPLICABILITY:<br><input checked="" type="checkbox"/> NA <input type="checkbox"/> MEA<br><input type="checkbox"/> SA <input type="checkbox"/> IAP<br><input type="checkbox"/> EE <input type="checkbox"/> CH | |

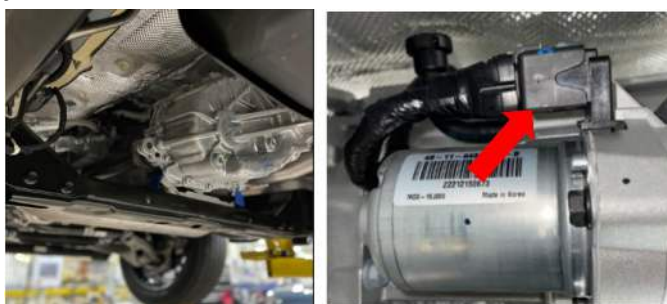
**Fig. 1**

| CAUSE: | Connector not fully seated. | | | | |

Transfer Case Shift Motor Wire Harness Connector

1. Raise and support the vehicle. Refer to the detailed service procedures available in DealerCONNECT/Service Library under: Service Info>04 - Vehicle Quick Reference / Hoisting / Standard Procedure.
2. Remove the transfer case skid plate, **if equipped**. Refer to the detailed service procedures available in DealerCONNECT/Service Library under: Service Info>13 - Frame and Bumpers / Under Body Protection / Plate, Skid / Removal.
3. Perform a push-pull-push test on the transfer case shift motor wire harness connector [Fig. 1](#) to verify the connector is fully seated.
